CERTIFIED ARBORIST REPORT

2090 SW Marine Dr, Vancouver

August 9, 2021

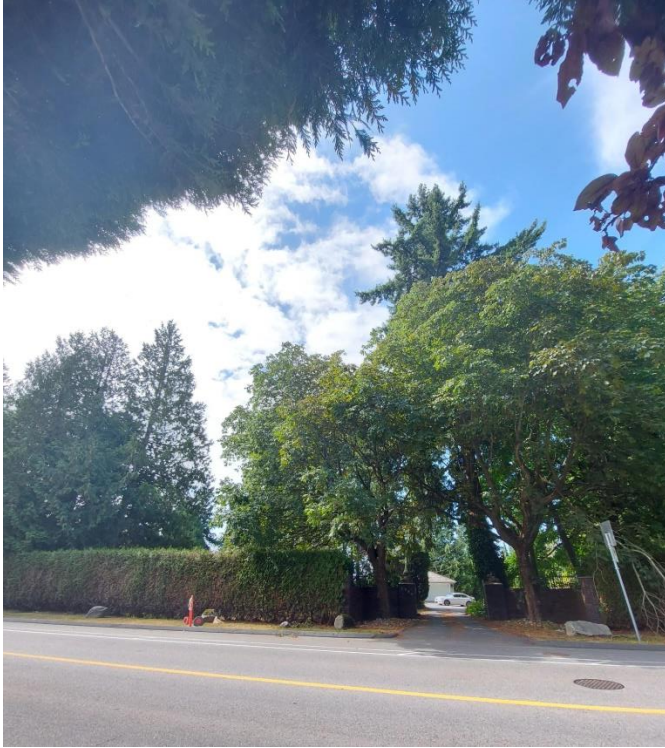
Photo 1 - Facing towards the frontage of the lot and of trees #1 and #2

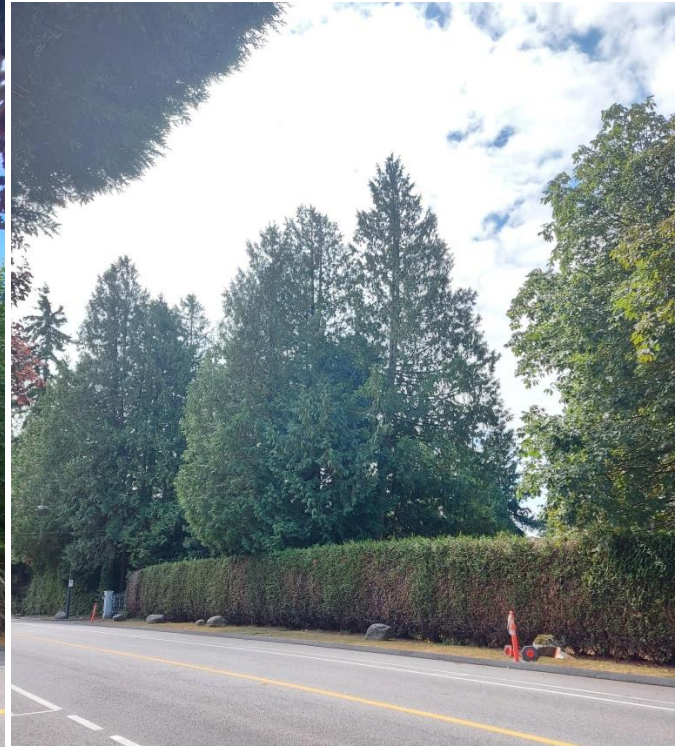
Photo 2 - Facing towards the frontage of the lot and of trees #4 - #8

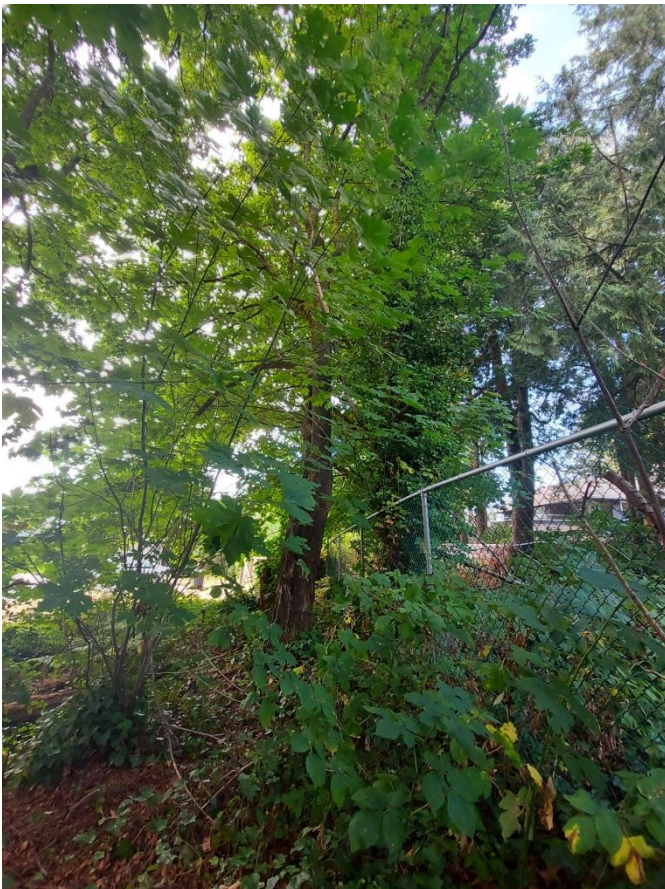
Photo 3 - Facing towards city trees #C1 - #C6

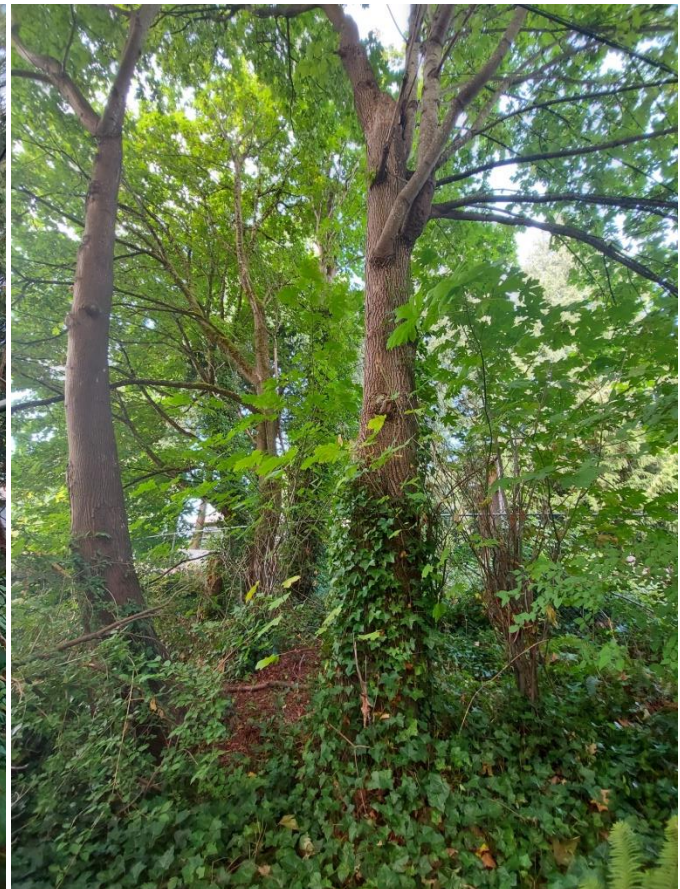
Photo 4 - Facing towards city trees #C1 - #C6

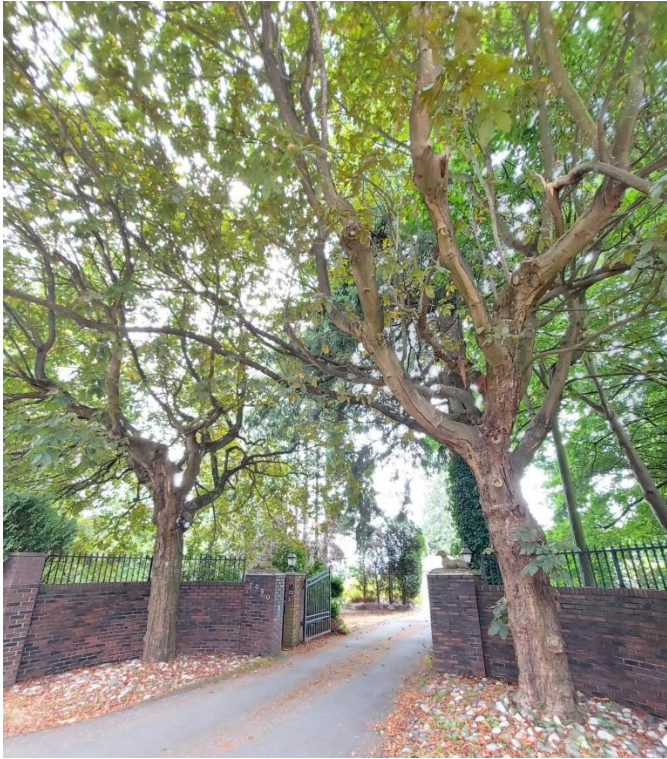
Photo 5 - Facing towards on-site trees #1 and #2

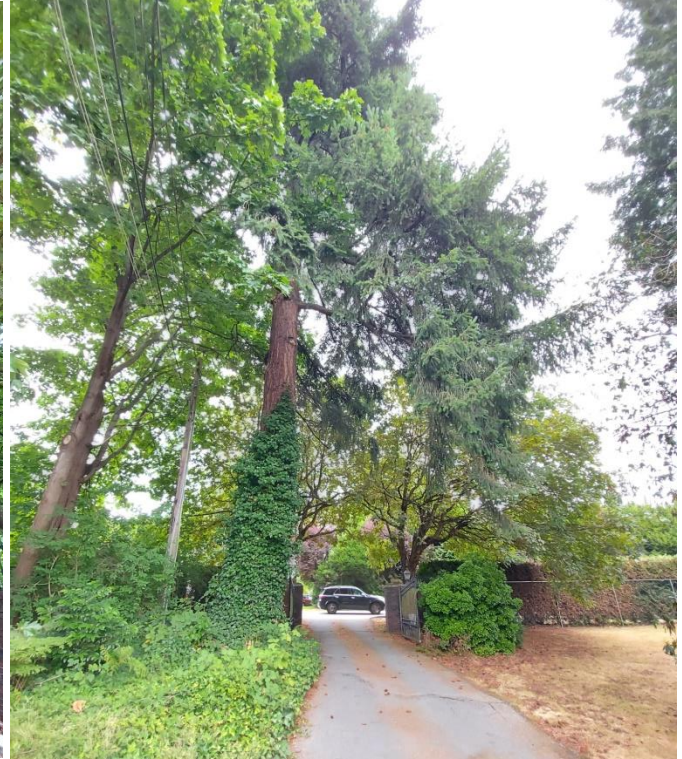
Photo 6 - Facing towards trees #1, #2, and #3

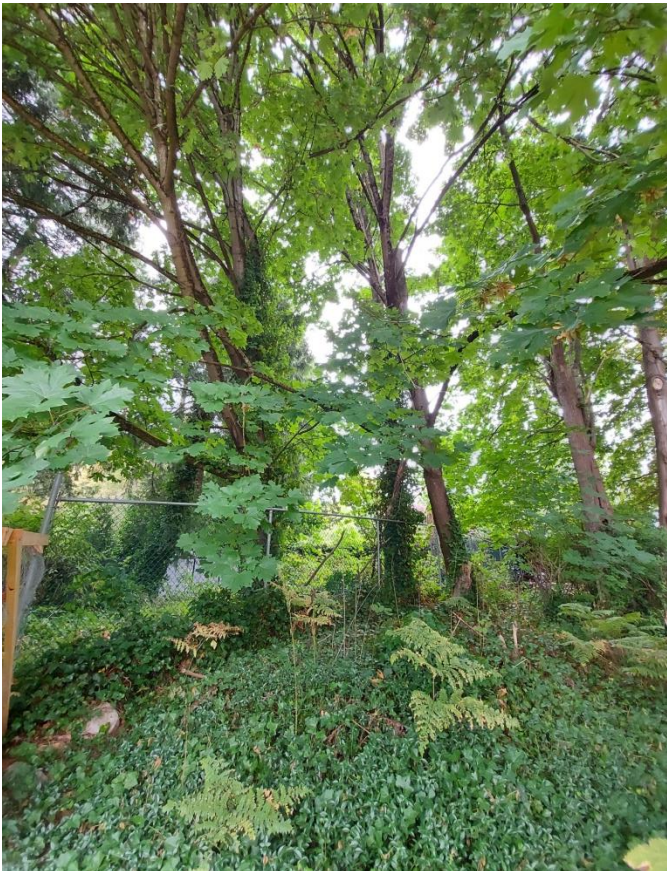
Photo 7 - Facing towards city trees #C1 - #C6

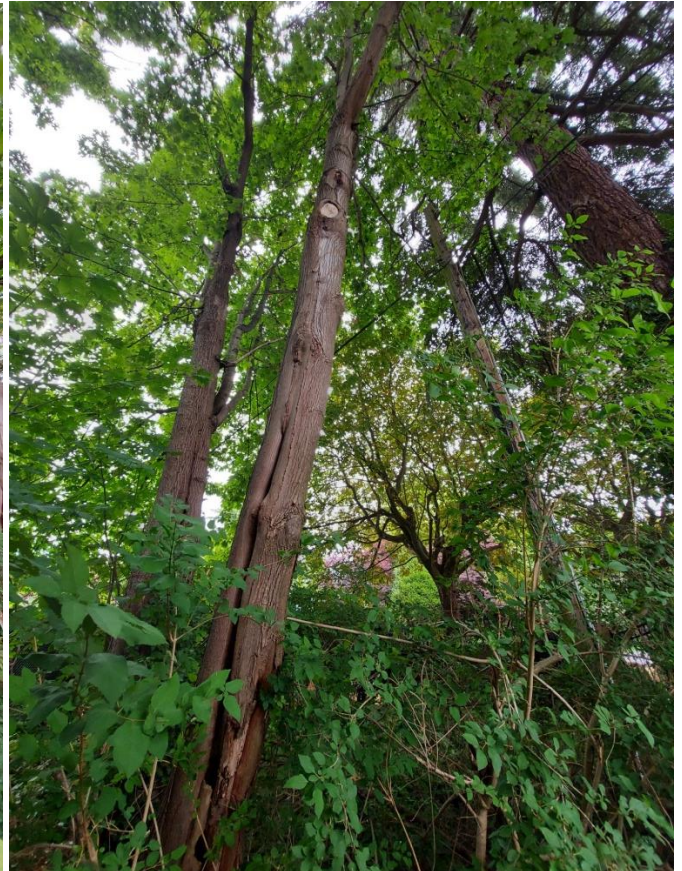
Photo 8 - Facing towards city trees #C1 - #C6

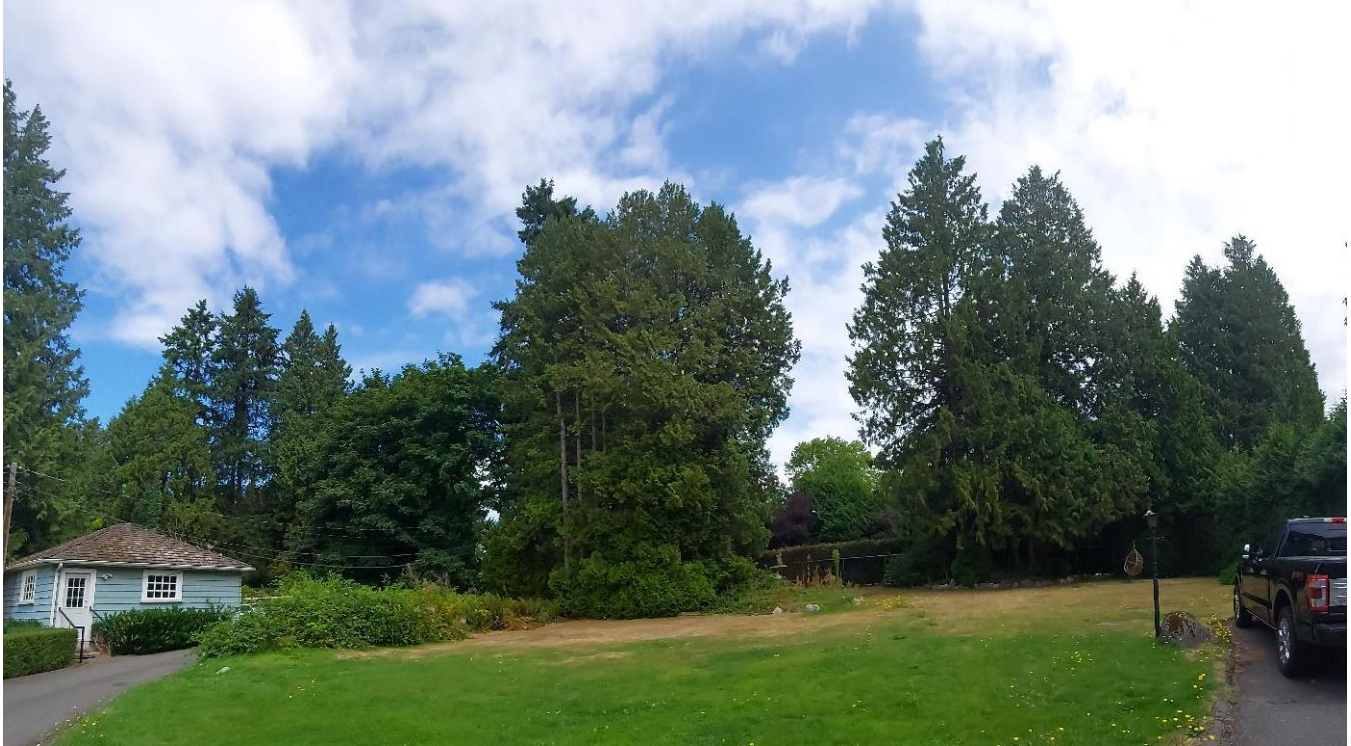
Photo 9 - Facing towards the trees spanning along the northern length of the lot

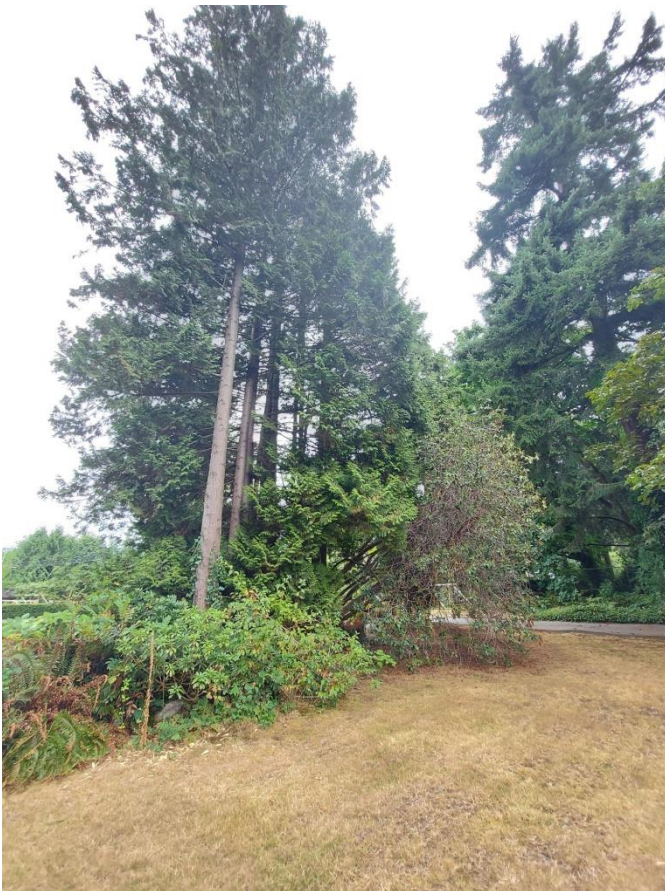
Photo 10 - Facing towards on-site trees #12 - #18

- **Conflicts with the proposed building footprint,**
On-site trees #12, #13, #14, #15, #16, #17, and #18 will be in direct conflict with the proposed development as the subject trees would fall towards the edge of the proposed building footprint and would be located within an area requiring the heaviest excavation & grading related requirements. The subject trees would be impacted and become structurally destabilized during the works as the trees would fall within an area requiring the heaviest grade disturbances related to the dwellings and of its perimeter excavation requirements.

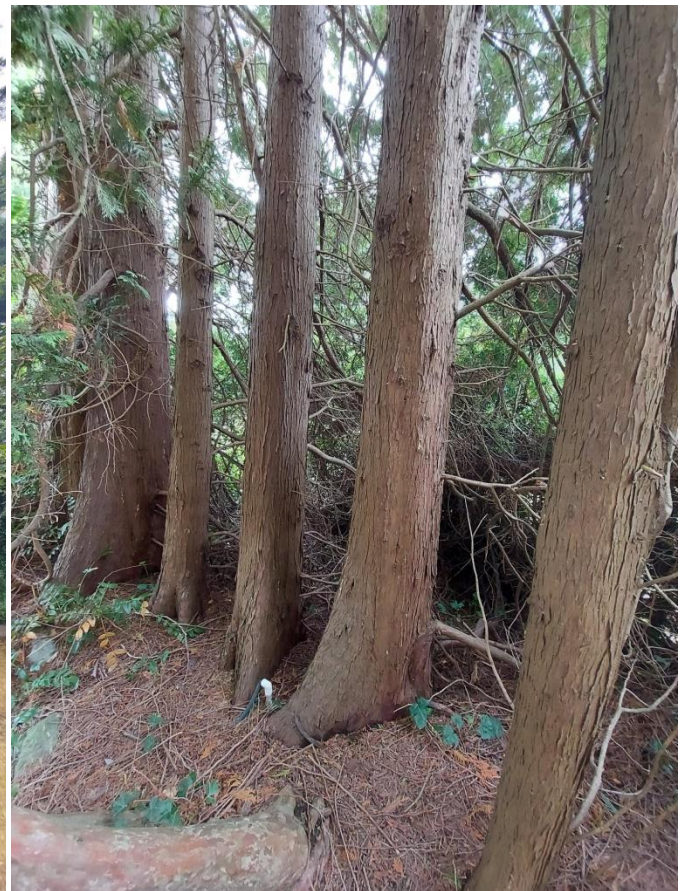
Photo 11 - Facing towards the lower trunk of on-site trees #12 - #18

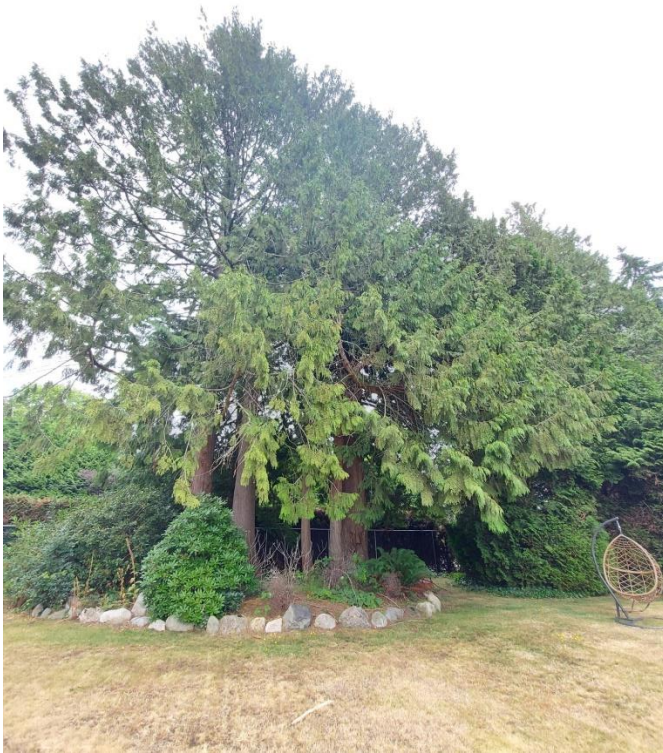
Photo 12 - Facing towards on-site trees #4 - #11

- **Conflicts with the proposed site servicing works,**
On-site trees #4, #5, #6, #7, #8, and #9 will be in direct conflict with the proposed development as the subject trees would fall towards the edge of the proposed service connections and would be located within an area requiring the heaviest excavation & servicing related requirements relating to the construction project. The subject trees would fall within an area requiring the heaviest grade disturbances related to the service connections and of its perimeter construction related requirements.

- **Proposed Driveway Conflicts**
On-site trees #10 and #11 will be in direct conflict with the proposed development as the subject trees would fall within the footprint of the proposed driveway and would be in direct conflict with its construction & grading related requirements. The subject trees would fall within an area of high disturbance requirements related to the development project and of the driveway’s construction requirements that would result in root loss & stability impacts.

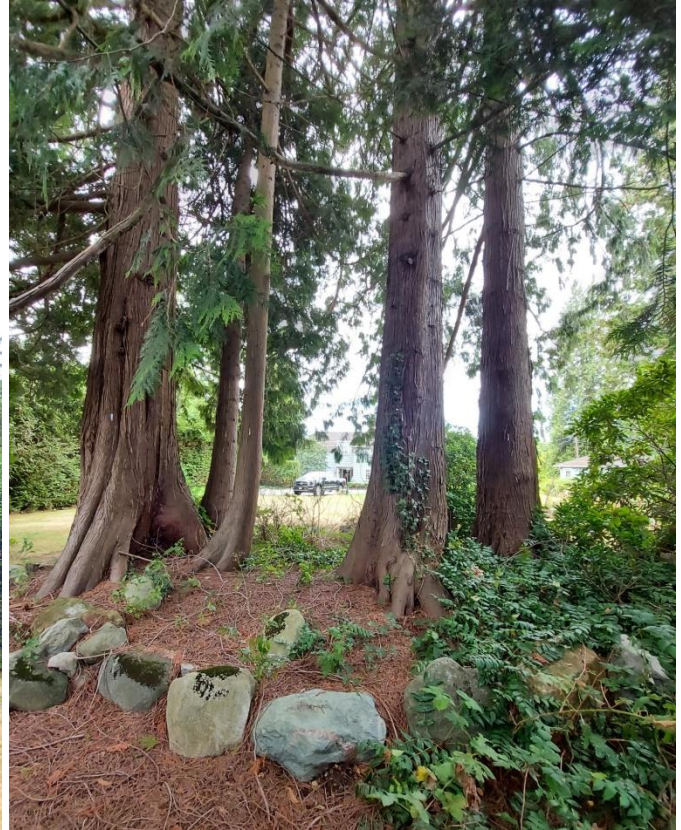
Photo 13 - Facing towards the lower trunk of trees #4 - #11

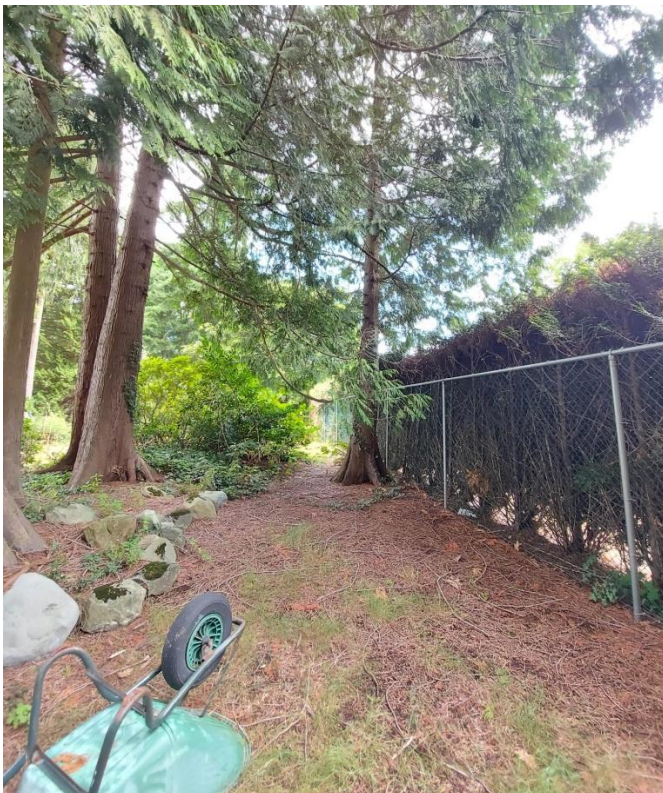
Photo 14 - Facing towards trees #4 - #7

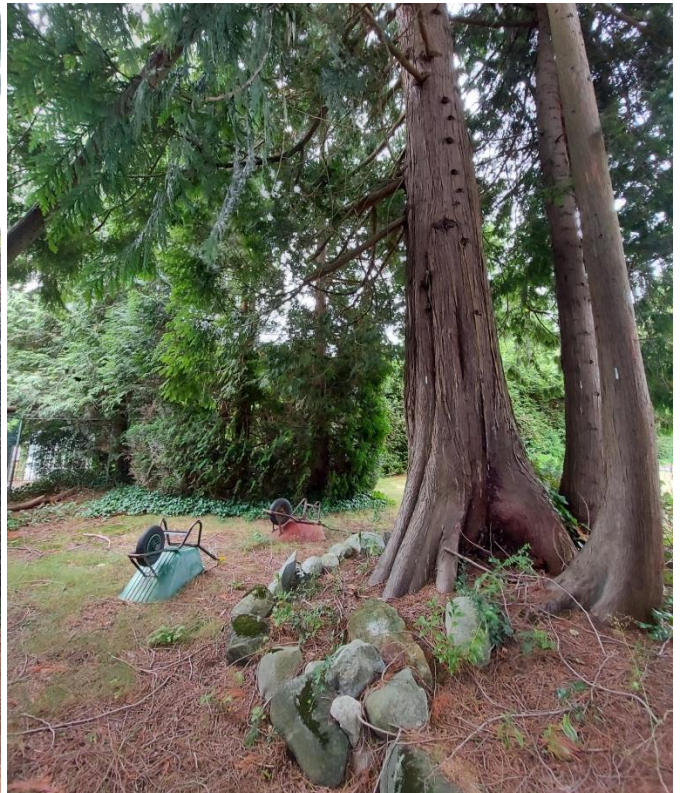
Photo 15 - Facing towards the lower trunk of trees #6, #5, and #7

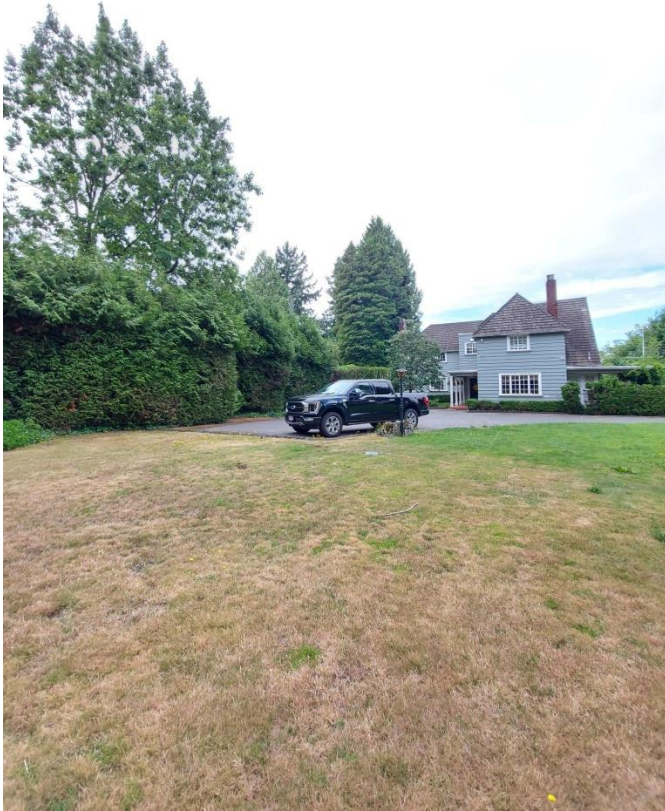
Photo 16 - Facing towards hedge #1 and of off-site tree #OS1

- A portion of **hedge #1** will be in direct conflict with the proposed development as sections of the hedging would fall towards the edge or would be in direct conflict with the proposed site access and would fall within an area requiring high disturbances related to the construction works occurring along the northern length of the site.
- On-site **hedge #2** may be required to be either cut back in order to allow for the construction process, building, & contractors general working clearance to take place. Only the portion of the hedging encroaching past the site boundary line and into the subject site would be required to be removed.

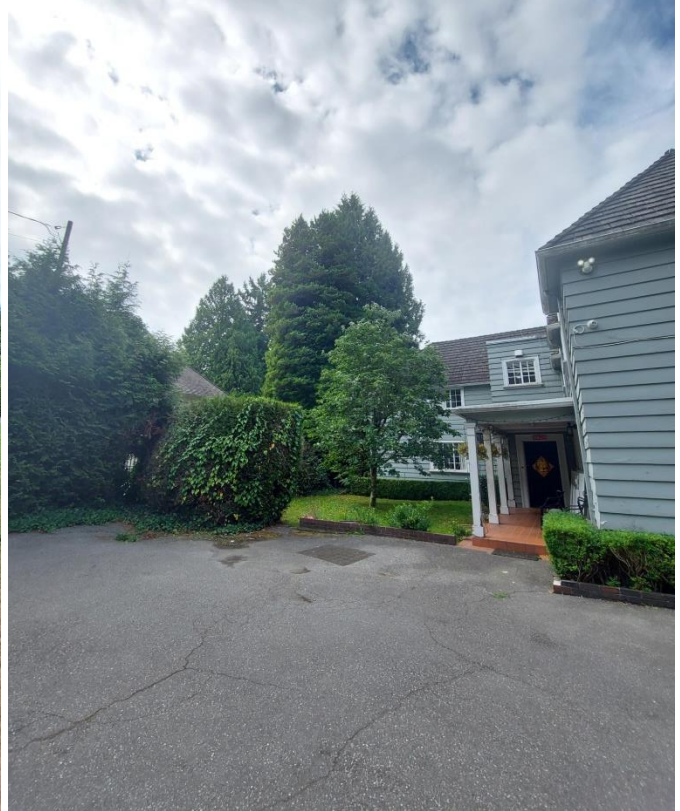
Photo 17 - Facing towards on-site tree #OS2 - #OS4

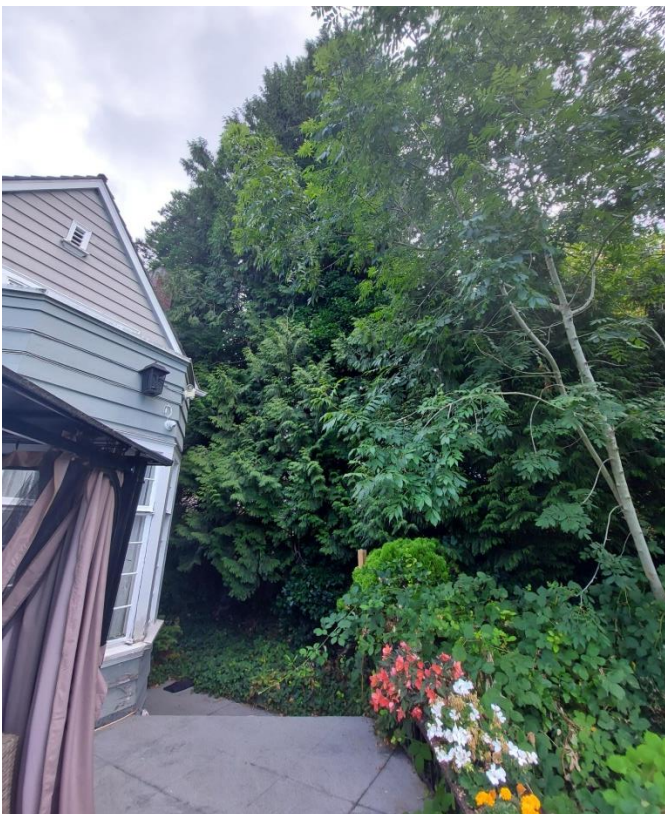
Photo 18 - Facing towards off-site trees #OS2 - #OS4

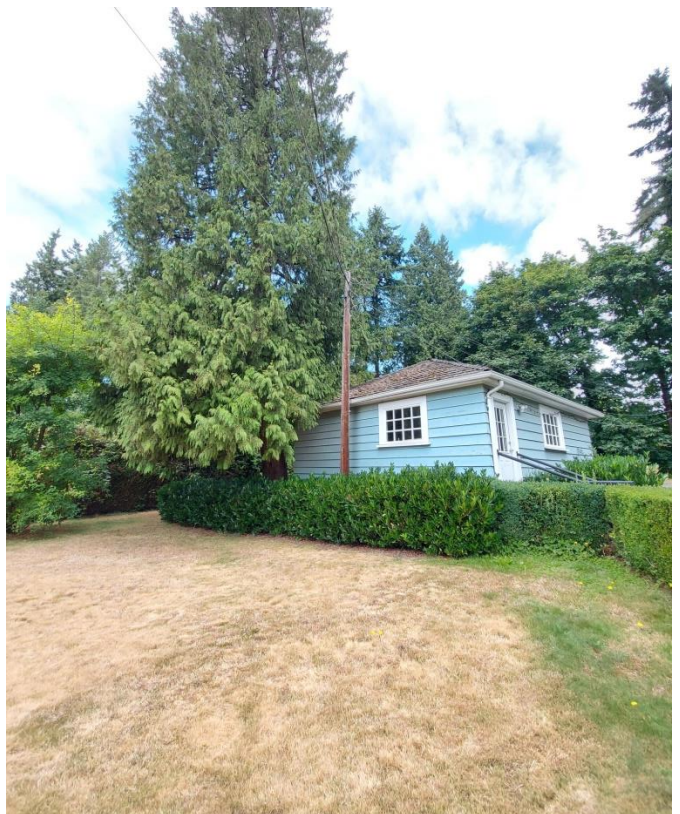
Photo 19 - Facing towards city tree #C7
