SERVICE BUILDING

800 GRANVILLE STREET, VANCOUVER, BC

CONSERVATION PLAN

OCTOBER 2022

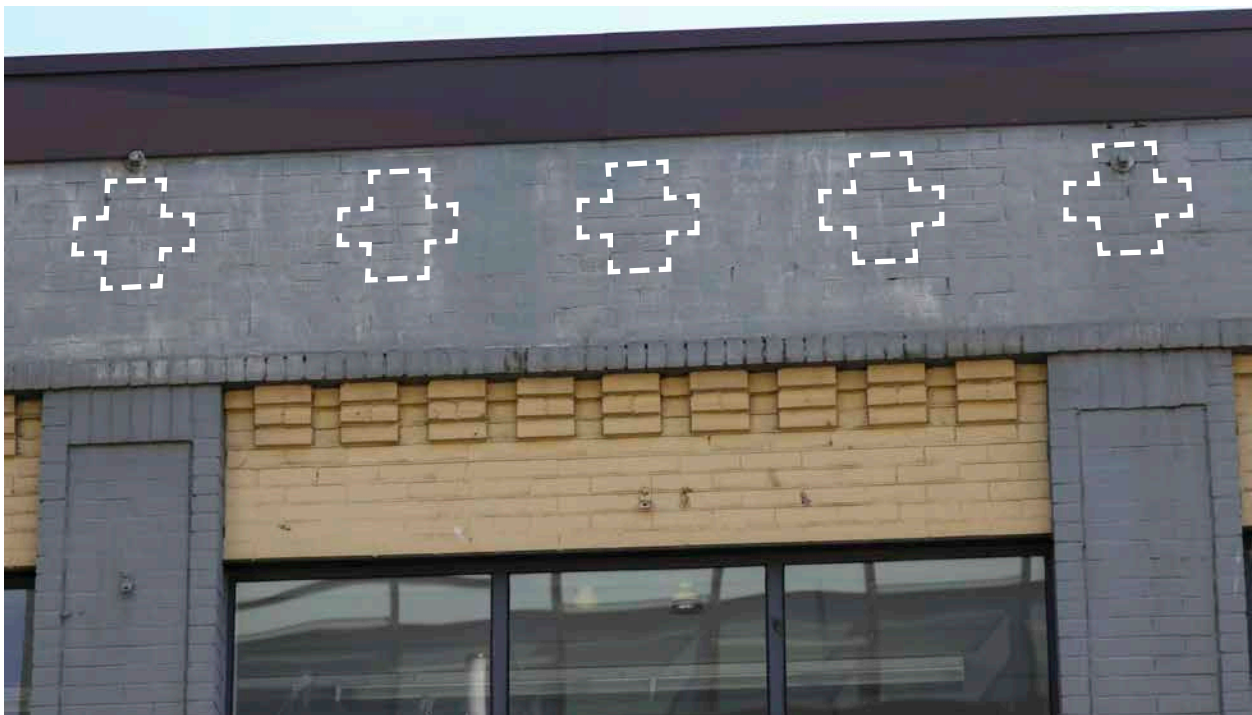
The Granville Street façade features four structural bays with a full-length street level storefront. The condition of the on this façade brick is fair, with visible deterioration in the form of efflorescence, organic growth, mortar loss, paint blistering and

Detail of brickwork along the second storey of Granville Street façade, July 2021. Original, decorative brickwork (outlined above) is evident but obscured by paint. (Donald Luxton & Associates)

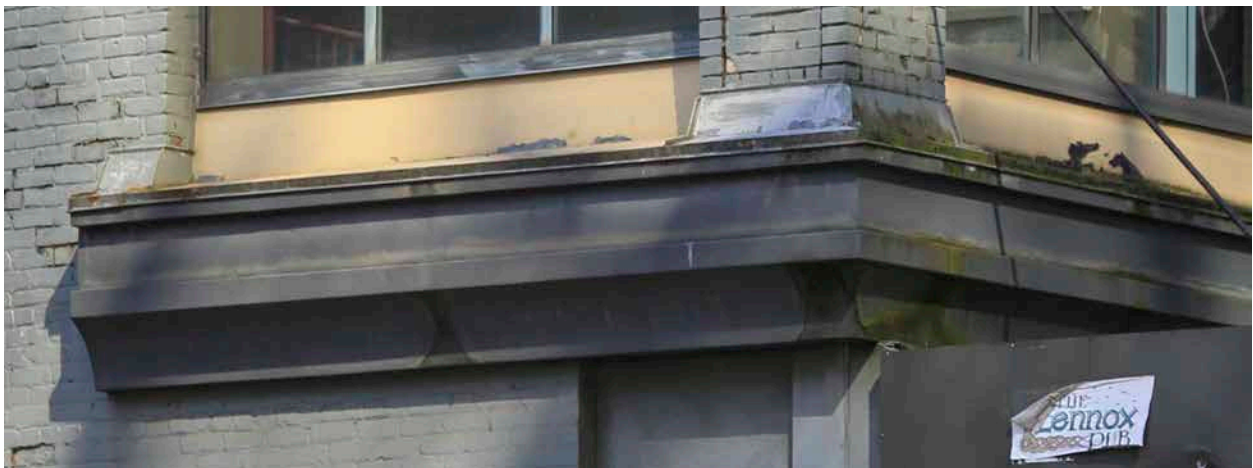
Present storefront cornice on the east corner of the Service Building, July 2021. This cornice is likely not original, and may be concealing the original storefront cornice behind it. (Donald Luxton & Associates)

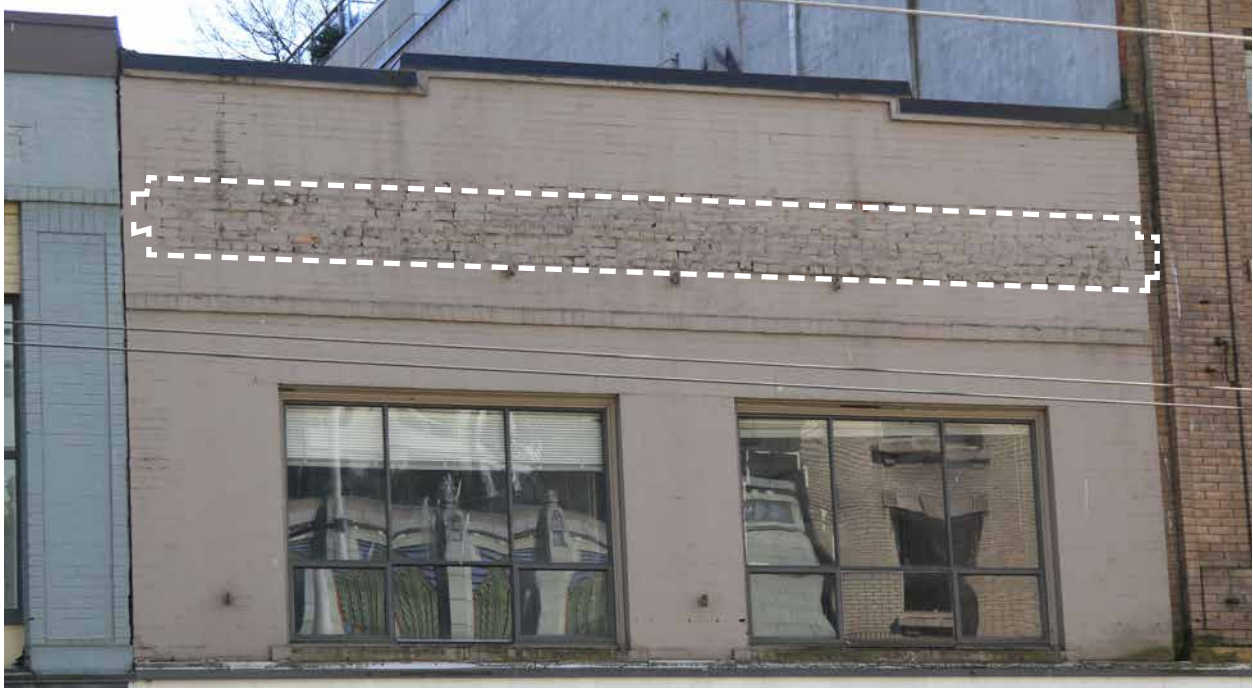
View of the upper floor of the front façade from Granville Street as it appeared in March 2021. Note outline of missing cornice. (Donald Luxton & Associates)

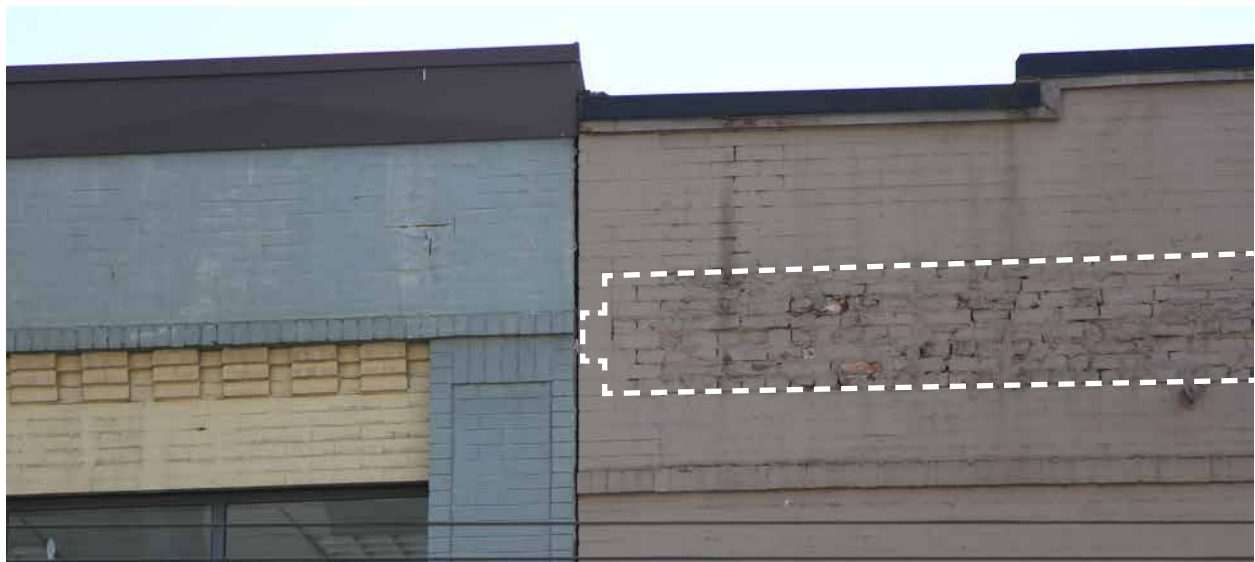
Detailed view of parapet wall corner showing outline of missing cornice and later added cap flashing as it appeared in March 2021. (Donald Luxton & Associates)

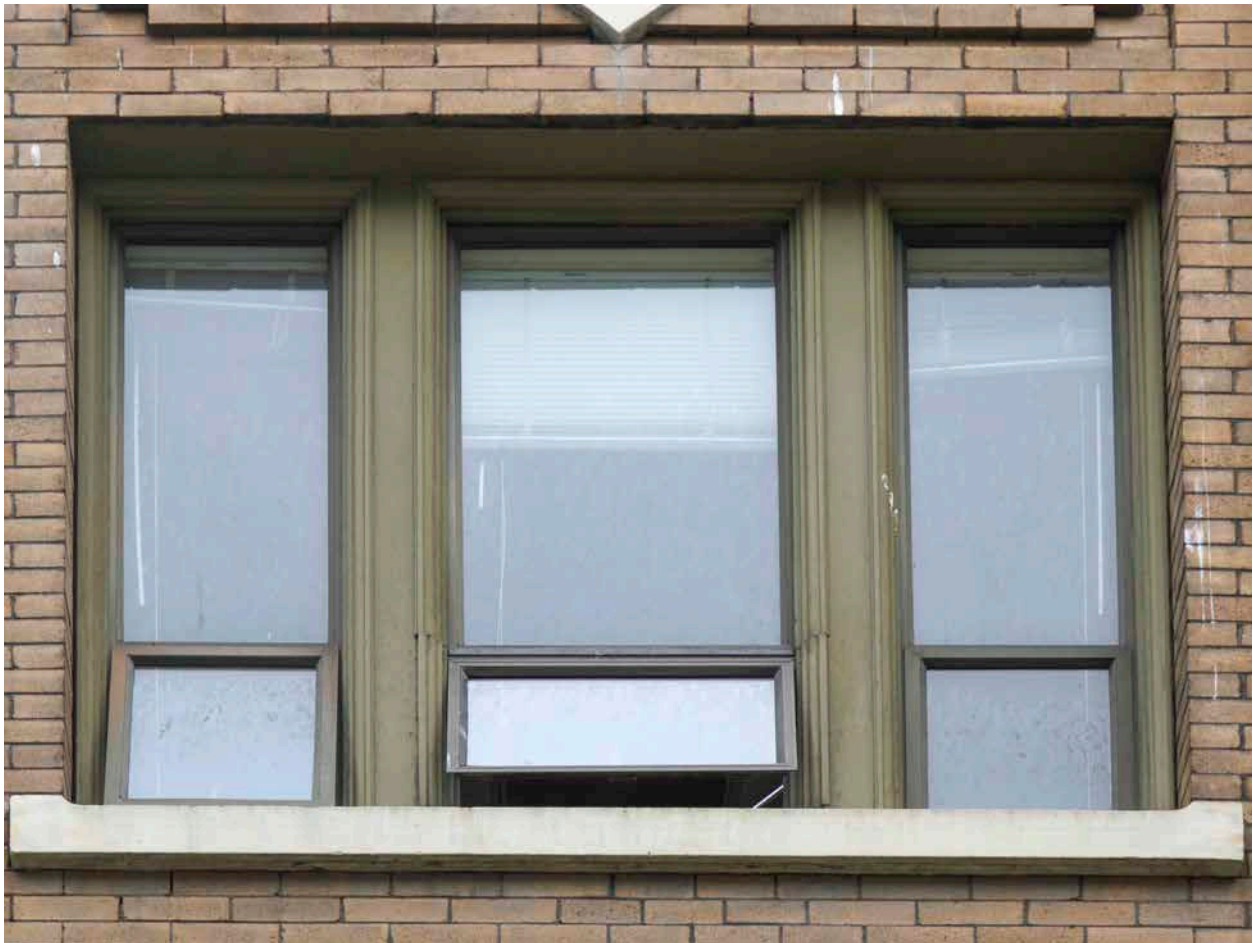
Front façade window with original wood frame and mullions, but with non-original sashes and glazing. (Donald Luxton & Associates)

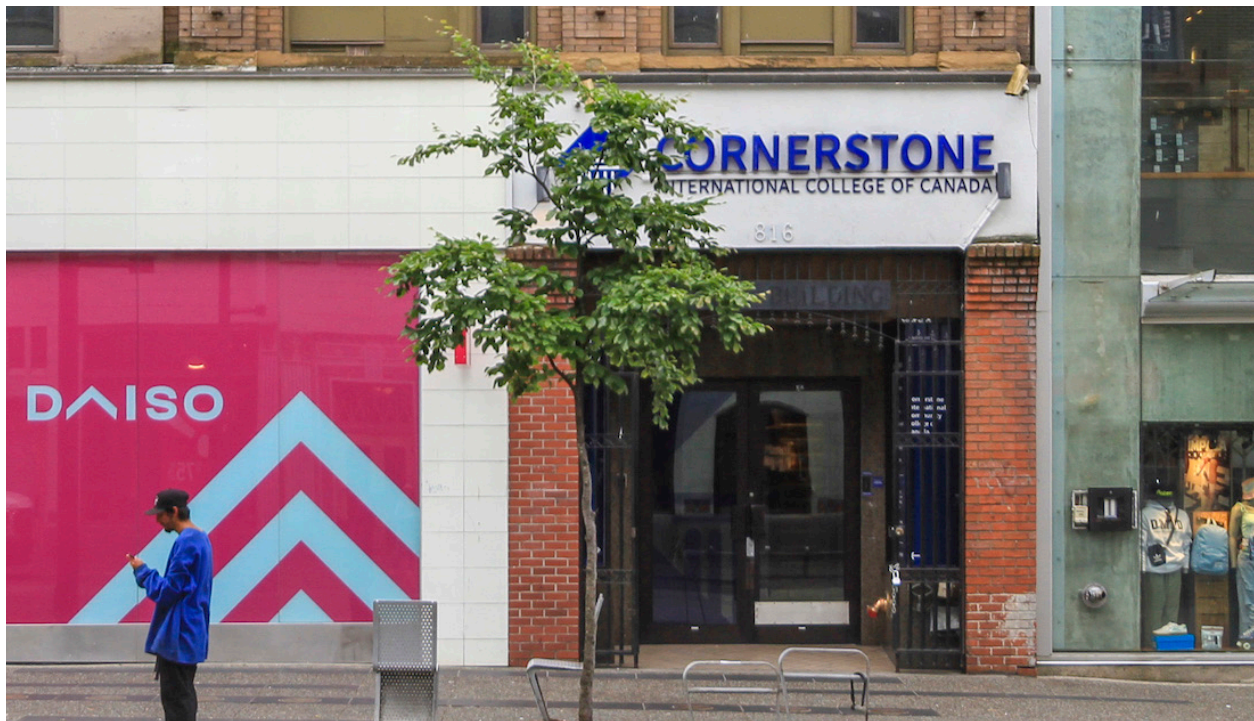
Existing storefront of Allen Rooms with significant alterations from the original design and materials. (Donald Luxton & Associates)

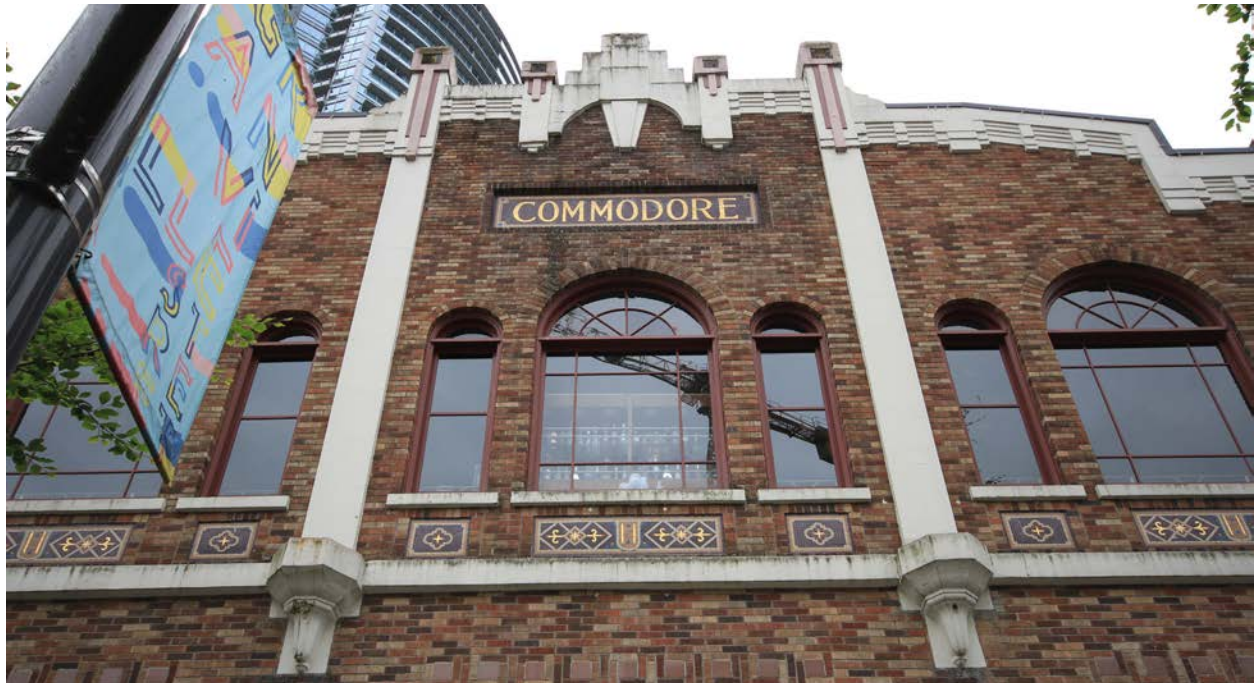
Central parged ziggurat and geometric detailing among the Commodore Ballroom's parapet. Pilasters with geometric details. Note staining on brickwork around 'COMMODORE' sign band and on horizontal sills.

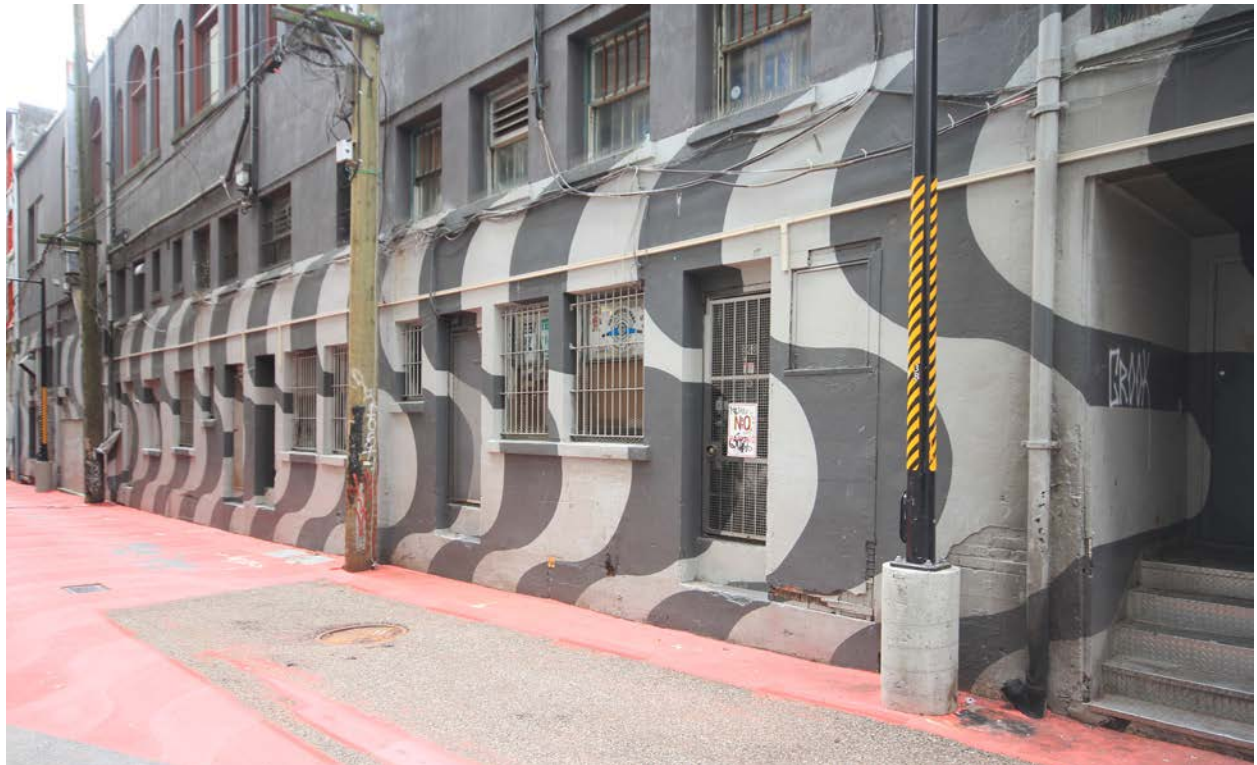
Rear façade of Commodore Ballroom showing parged brickwork with parging failing at right.

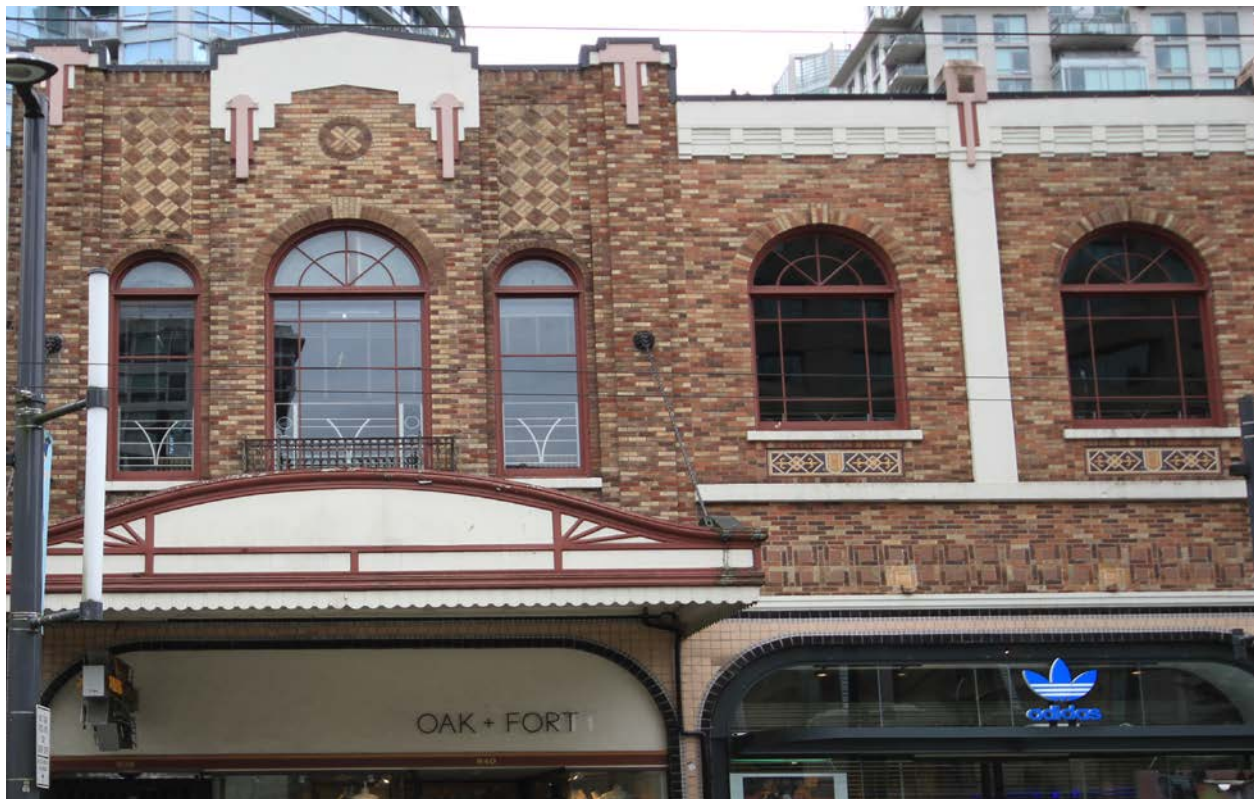
Single and triple assembly windows of the second floor of the front façade. Original wood jambs and sashes are largely intact; however, some sashes and glazing have been replaced.

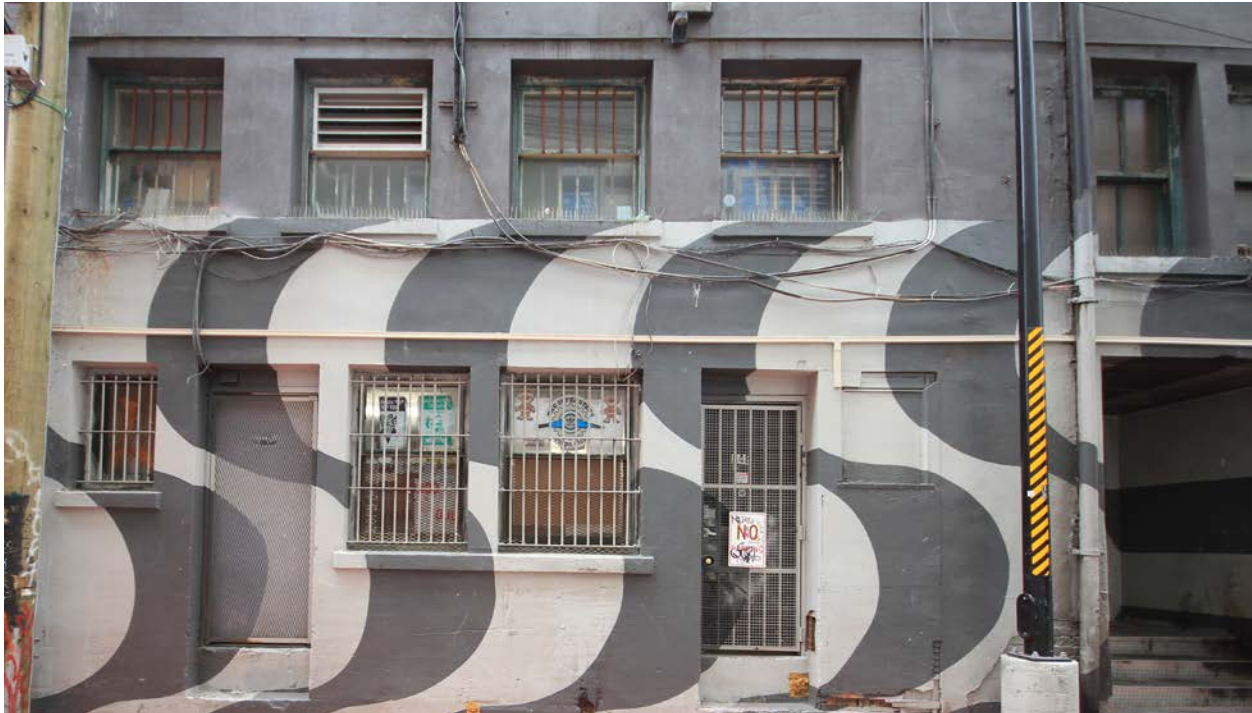
Rear façade of Commodore Ballroom with metal hung windows. Some of the windows have been altered, contain broken glass, openings filled in, or have bars installed in the window openings.
