envirowest consultants inc.

September 24, 2021

**RE: BROADWAY & COMMERCIAL, VANCOUVER
ENVIRONMENTAL IMPACT ASSESSMENT UPDATE**

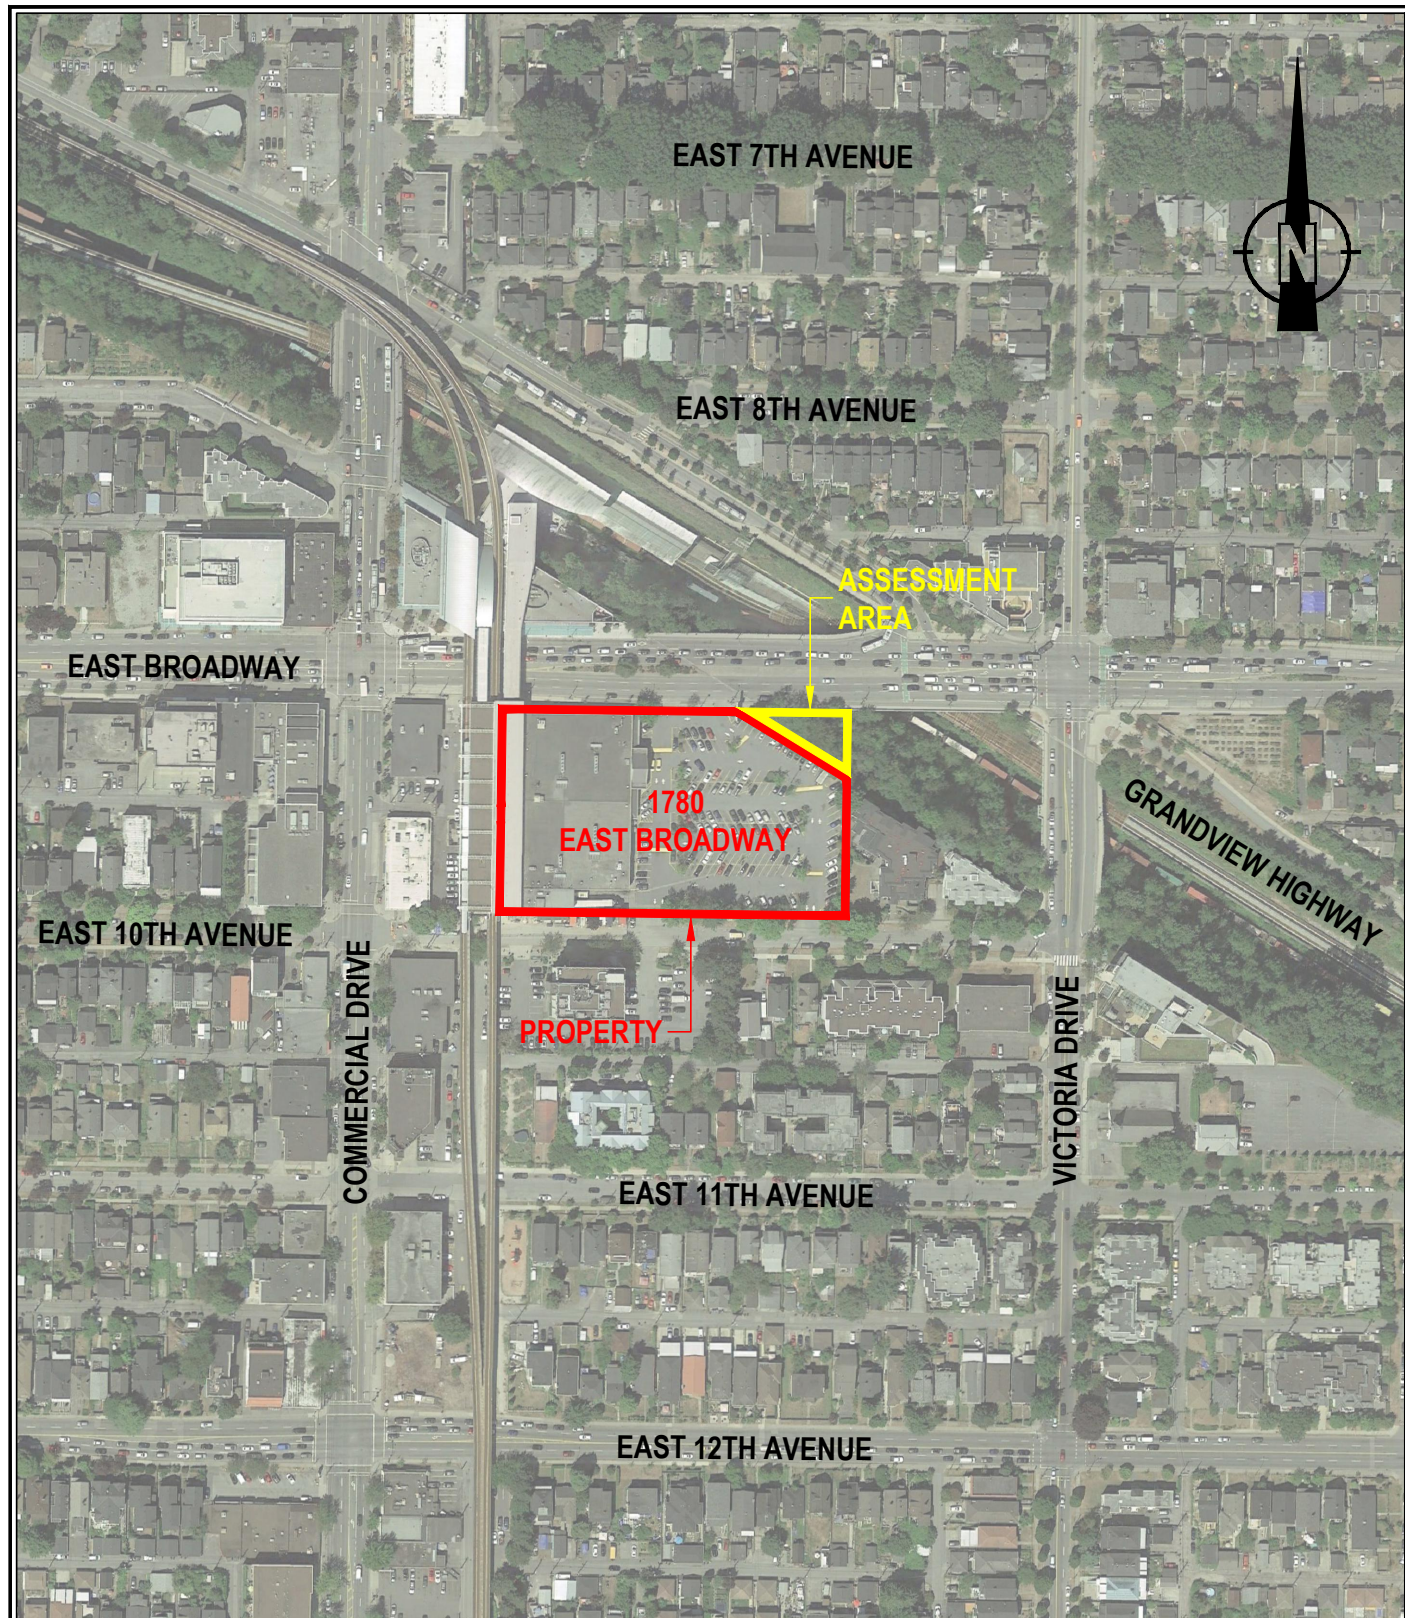
ATTACHMENT A
Assessment Area Location

DATE: 2021-09-23 - 3:47pm
PATH: \\ENV-FSR\Alpha\Envirowest Files\2021\Vanou ver\2669-01\AutoCAD\Final\Figure 1 - Assessment Area Location.dwg
LAYOUT: FIGURE 1

The location of the proposed ramps (biophysical inventory assessment area) is presented in Attachment A. Details of the proposed ramp footprint are presented in Attachment B. Representative site photographs are presented in Attachment C. A drawing from the solar study for the Project is included as Attachment D.

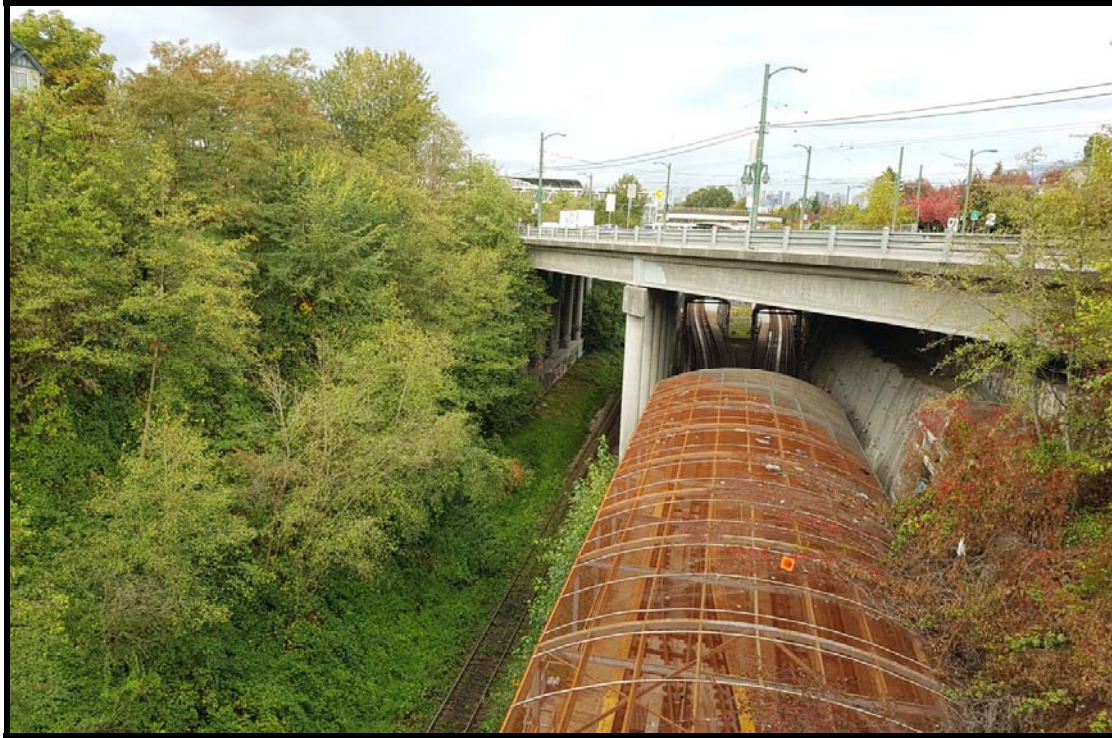
Photograph C1. Grandview Cut surrounding assessment area, looking northwest from Victoria Drive bridge (September 12, 2018). Visible in photograph: train tracks (middle), SkyTrain tracks (right), Broadway bridge (background), and assessment area (left of Broadway bridge).

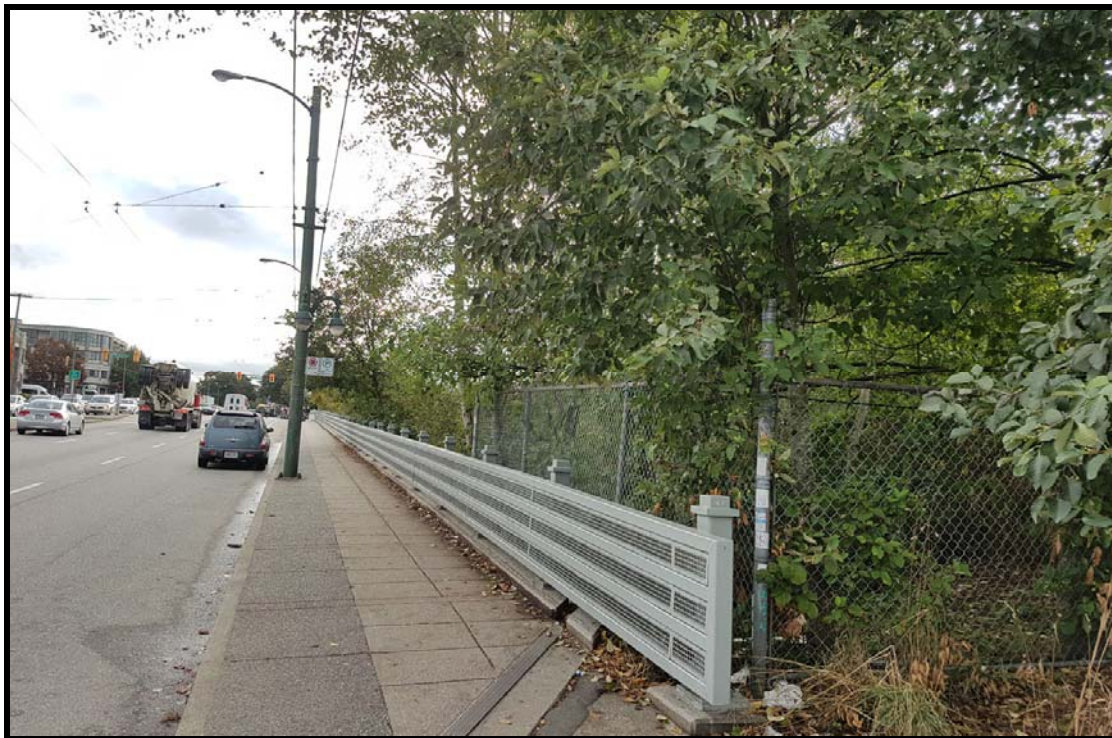
Photograph C2. Northern boundary of assessment area from street level, looking east-southeast from northwest corner of assessment area (September 12, 2018).

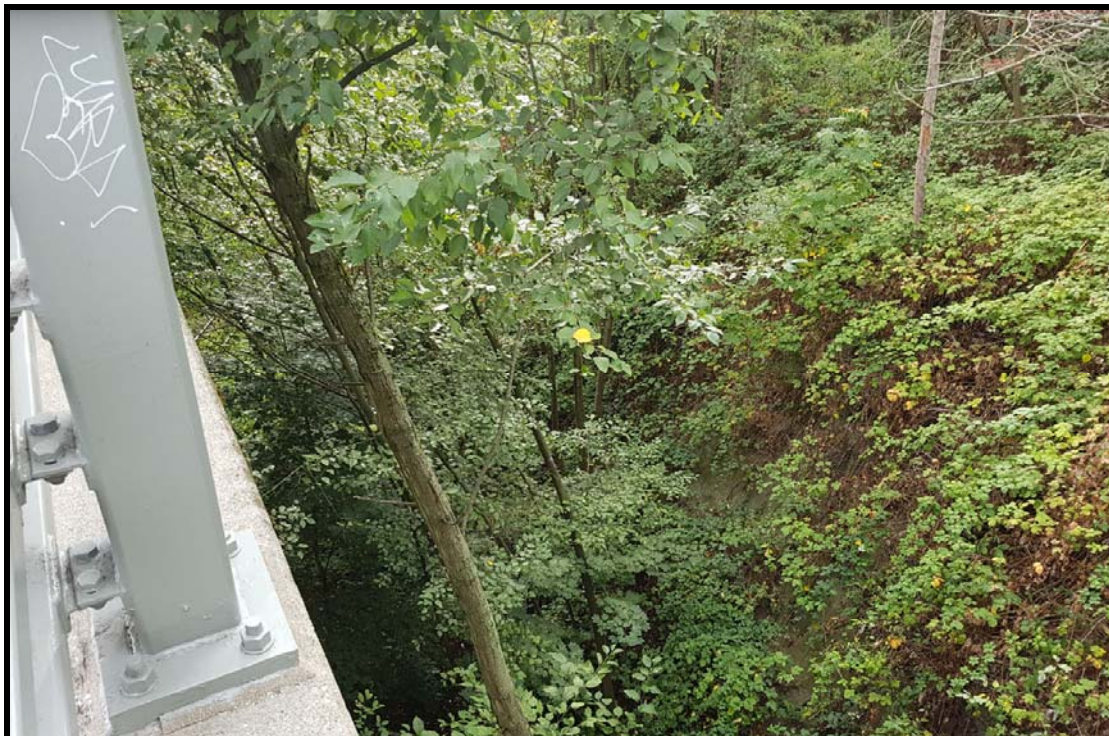
Photograph C3. Upper slope and mid-slope section of assessment area from street level, looking east-southeast and down into Grandview Cut from East Broadway (September 12, 2018).

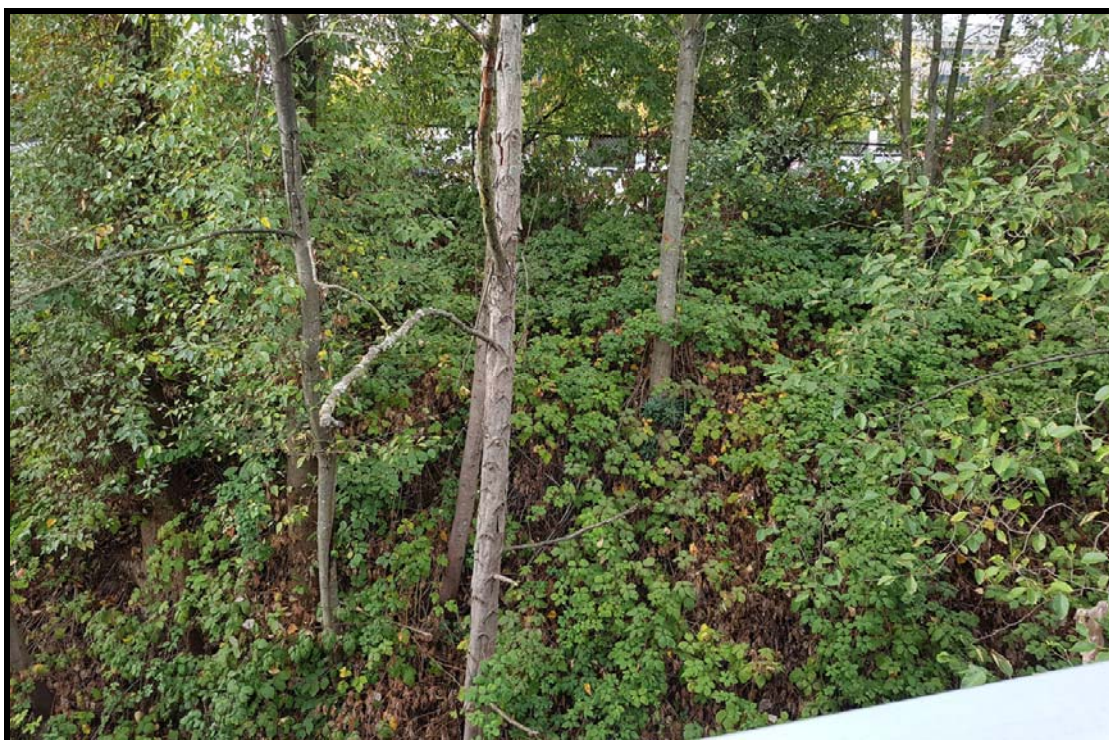
Photograph C4. Upper slope of assessment area from street level, looking southwest from East Broadway (September 12, 2018).

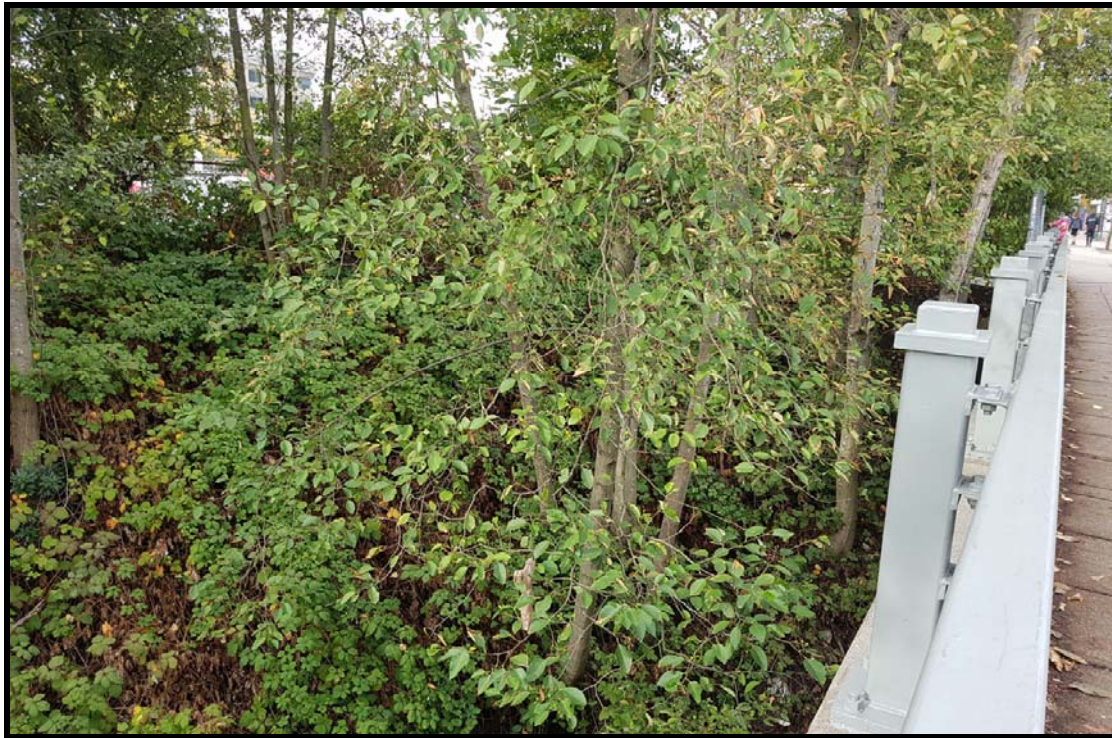
Photograph C5. Upper slope of assessment area from street level, looking west-southwest from East Broadway (September 12, 2018).

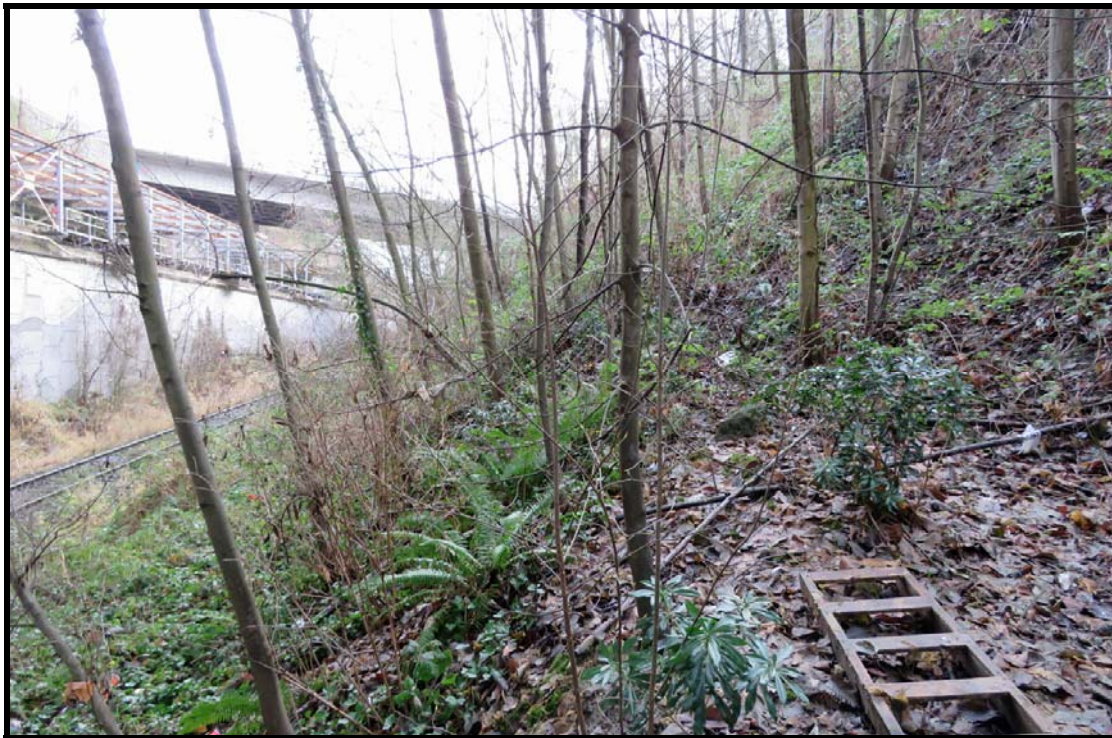
Photograph C6. Lower and middle slope of assessment area, looking southeast from beneath edge of Broadway bridge (December 19, 2018).

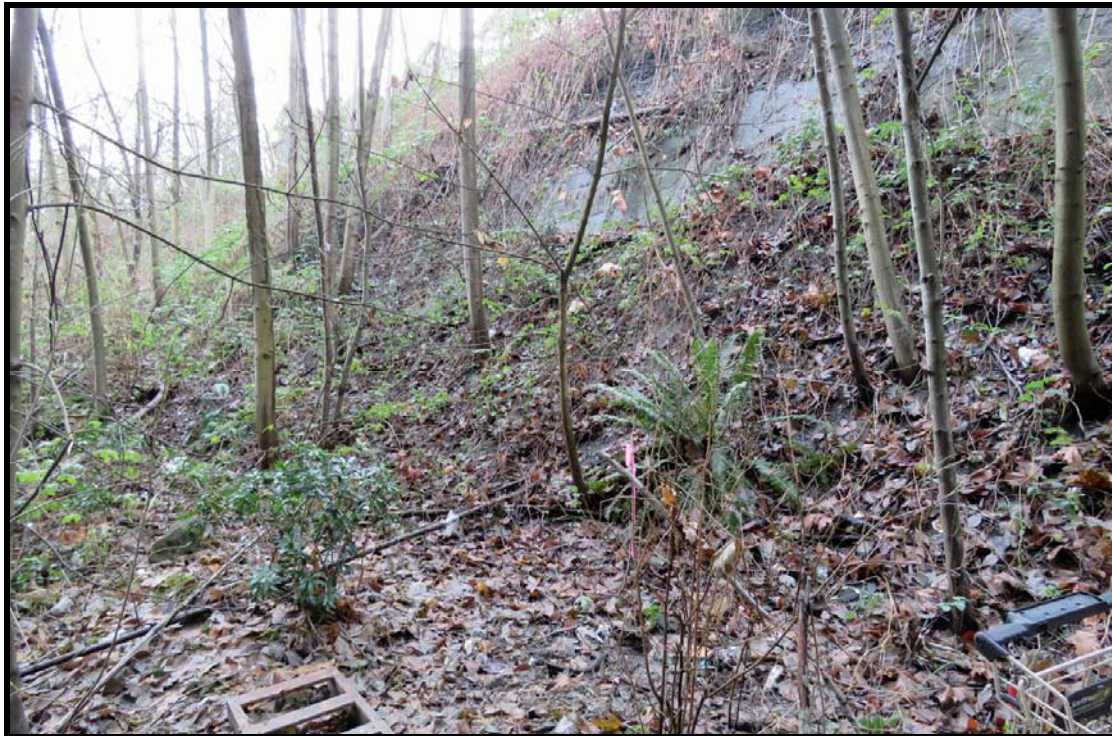
Photograph C7. Middle and upper slope of assessment area, looking south from beneath edge of Broadway bridge (December 19, 2018).

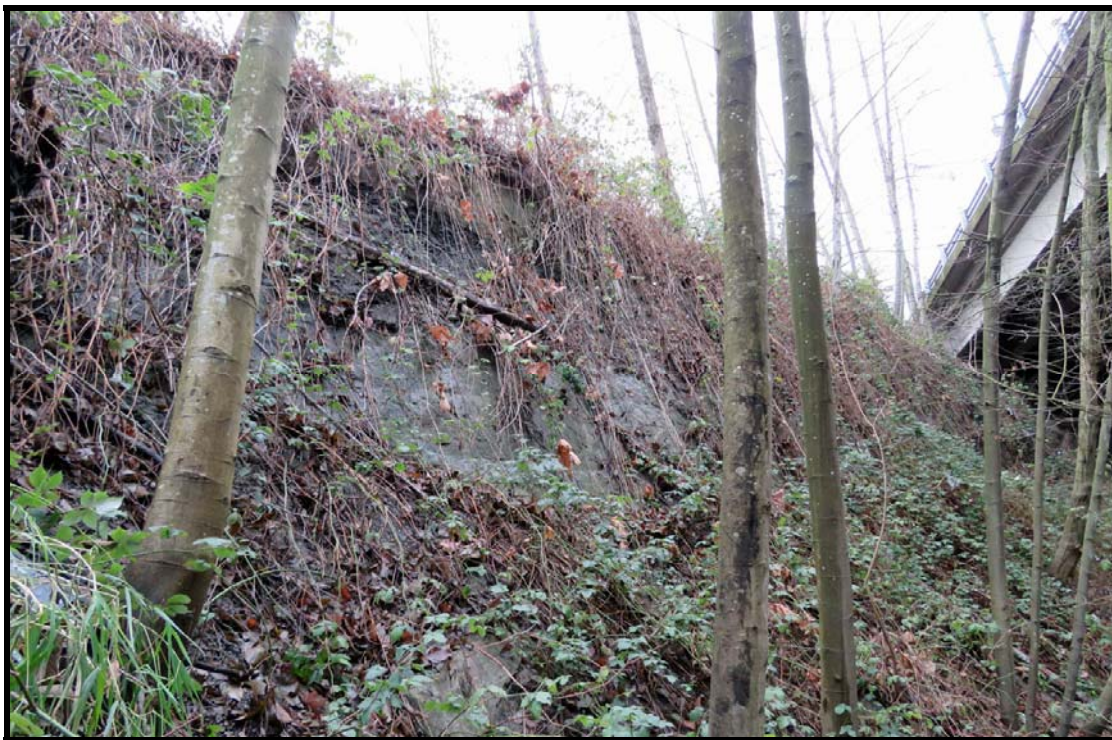
Photograph C8. Upper slope of assessment area, looking west from eastern extent of assessment area (December 19, 2018).

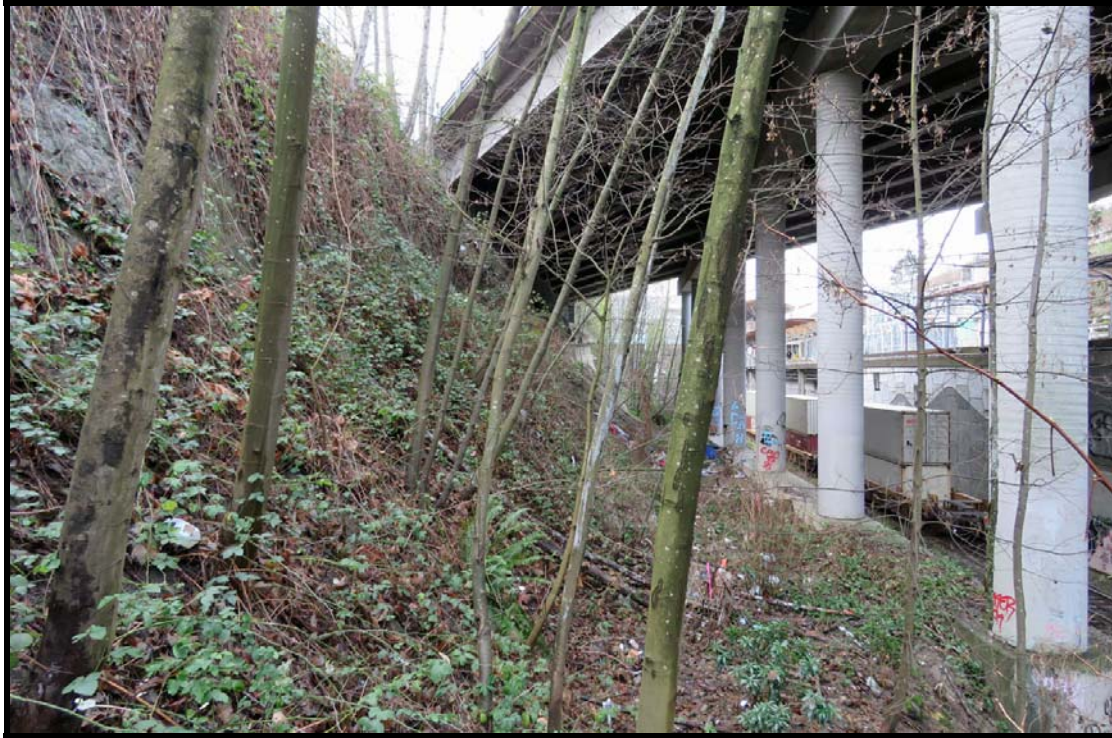
Photograph C9. Middle and lower slope of assessment area, looking northwest from eastern extent of assessment area (December 19, 2018).

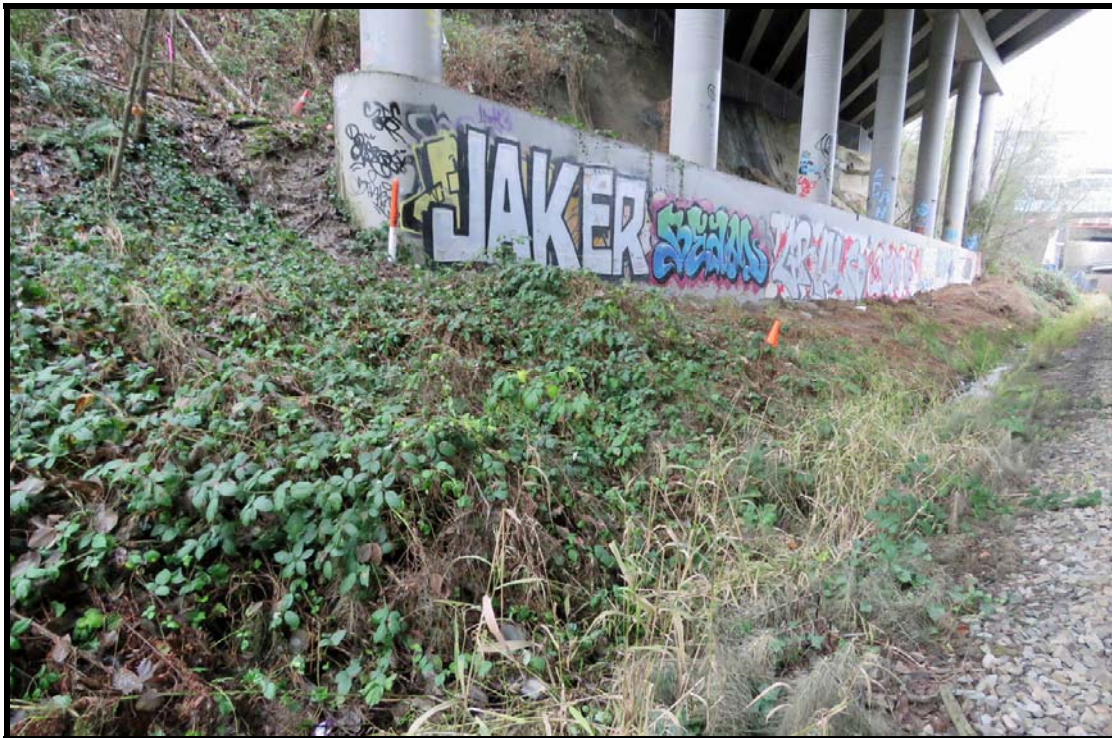
Photograph C10. Pier 1 of Broadway bridge and railway ditch, looking approximately west from northeast corner of assessment area (December 19, 2018).

The slope continues down into the rail right-of-way before flattening out surrounding the tracks. The columns and deflection wall of Pier 1 of the Broadway bridge are aligned immediately upslope of and parallel to the rail right-of-way, under the bridge immediately north of the proposed ramp location (Attachment B).
