# VANCOUVER GENERAL HOSPITAL HEATHER PAVILION

## Conservation Management Plan

**Project # 25-120**

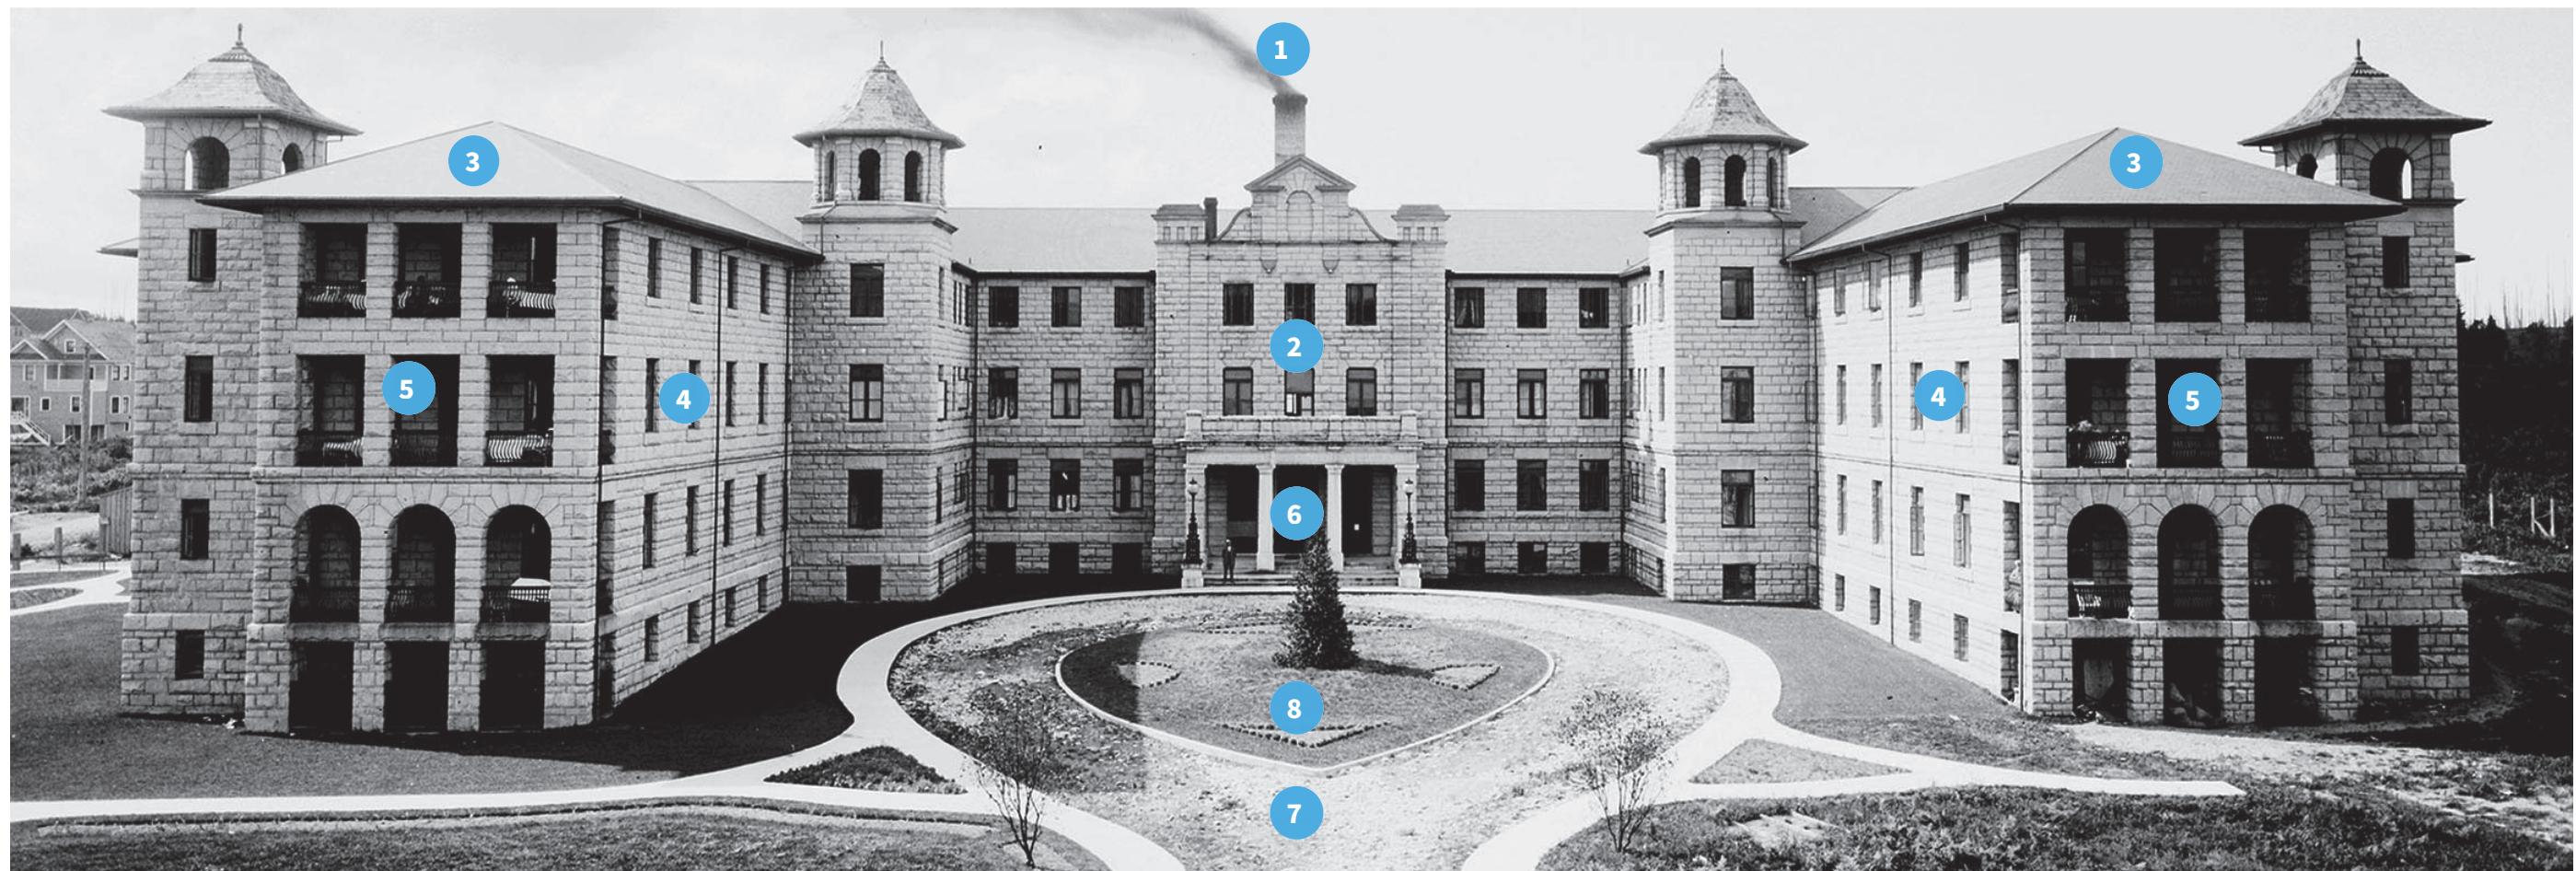
1. Pavilion style building Plan surrounded by fresh air and access to natural light
2. Central administration building, flanked by long and narrow patient wards
3. Large open wards, with patients organized into parallel rows of narrow beds
4. Cross-axial window arrangement
5. "Sun Porch" Balconies and towers
6. Formal entrance with ornate architectural detailing
7. Circular driveway
8. Landscaped forecourt

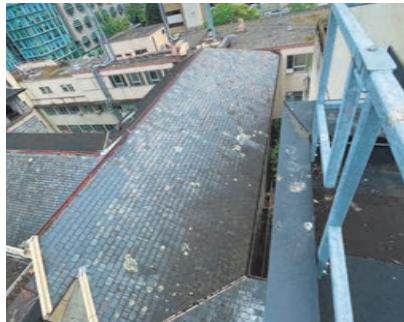
The hipped roofs of the 1906 wings have original slate tile roofs that are in poor condition. Multiple tiles are missing, cracked, or slipping. Moss and lichen are growing in shaded areas and staining from the zinc vent pipes (potentially galvanized) is evident. Flashings are a mix of decorative metal and copper that have sections of corrosion and open seams.

6. 1906 northeast hipped roof, looking east

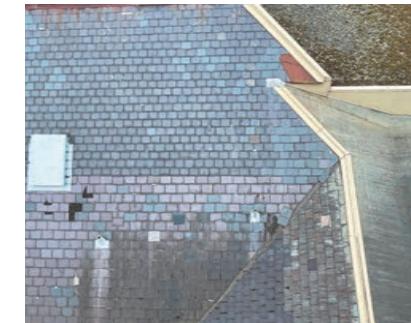
11. Roof staining and moss

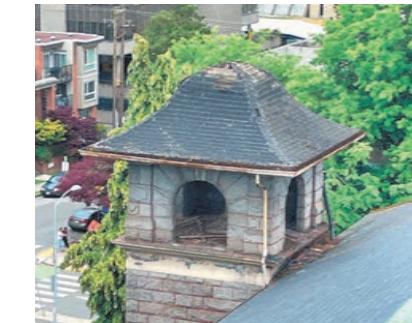
12. 1906 west wing, northwest tower roof

The three remaining bell cast roofs (one of each of the two 1906 wings, and one on the southeast wing) are slate tile roofs in defective condition. Evidence of minor maintenance can be seen, but the wooden roof structures have deteriorated to the point of collapse, and the arched open-air turrets appear to be housing pigeons and are in various states of disrepair. The painted metal decorative cornices are in fair condition. The gutters are in poor to defective condition. Eavestroughs and downspouts are rusted and often detached. The 1906 towers have downspouts.

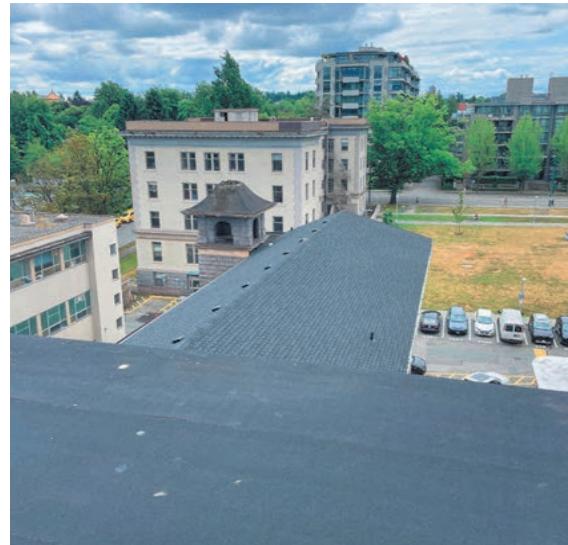
16. 1909 southeast tower from roof

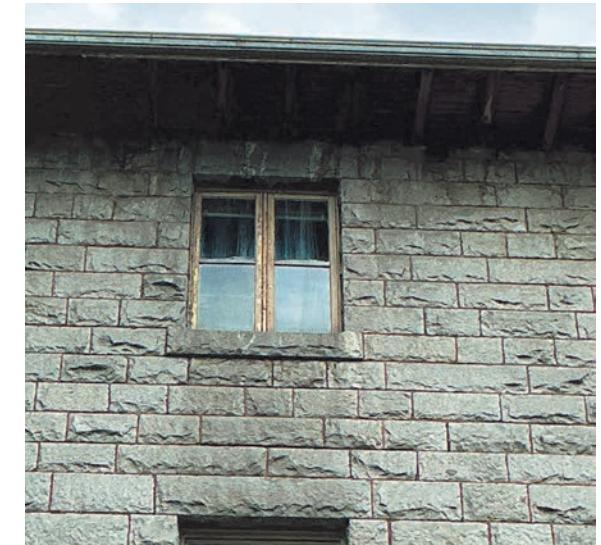
Half-round gutters are in defective condition, deformed due to impact and have rusted through in areas. Some downspouts have come disconnected from the eavestroughs. The original eaves have exposed rafter tails with unpainted tongue and groove soffits that are in poor condition under the original slate roofing. In some areas of the roofs, they have visible dry rot and have deteriorated to defective condition.

18. Soffit condition

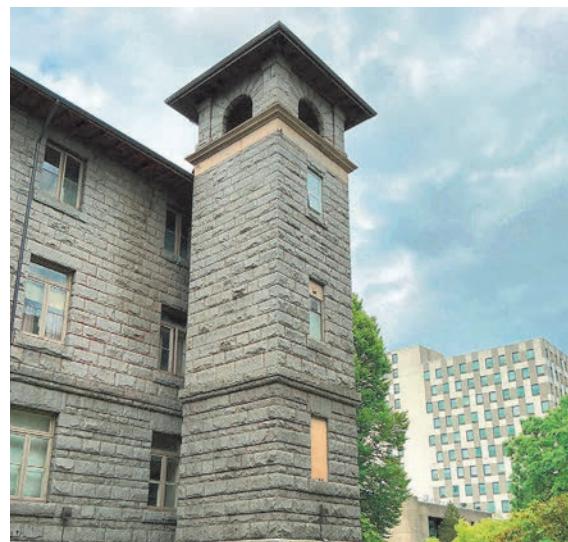
19. 1906 east wing, northeast tower

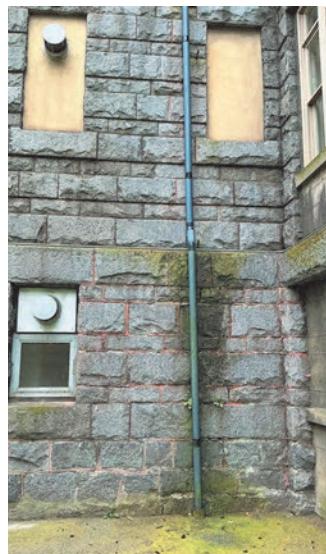
The coursed rock-faced ashlar granite is in fair condition. There is some mortar loss and localized biological growth in shadowed areas and minor staining and surface erosion typical of age. The monolithic granite sills

28. Typical biological growth

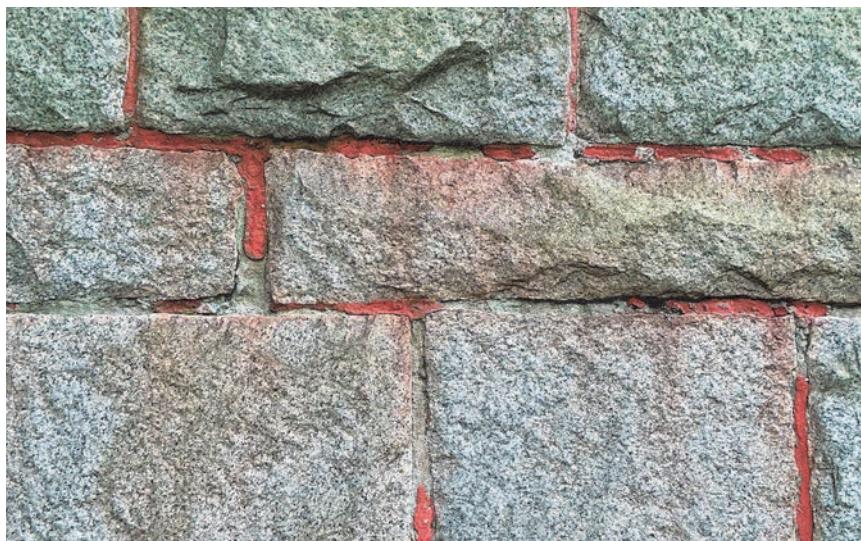
The ashlar granite masonry joints have been tuckpointed with red brick dust mortar. The tuck pointing is in poor condition and is deteriorating and/or missing on most of the building. It is delaminating and friable in many locations around the building.

29. Typical tuckpointing

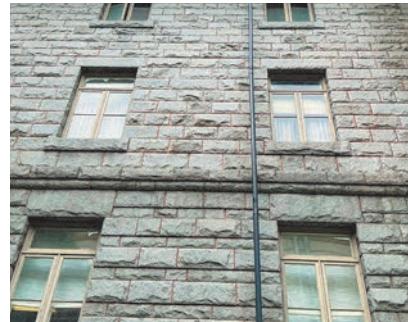
Original window openings are generally intact, but the units themselves vary widely in condition and originality. Original units appear to be a mix of casement windows, some of which have transoms above, and wood-sash double-hung windows. They range from poor to defective condition. There is evidence of widespread paint failure, warped frames, open joints, infilled glazing, and rot. Many have non-original aluminum storm windows, vents or security bars that are in poor condition.

33. 1906 east wing (partial)

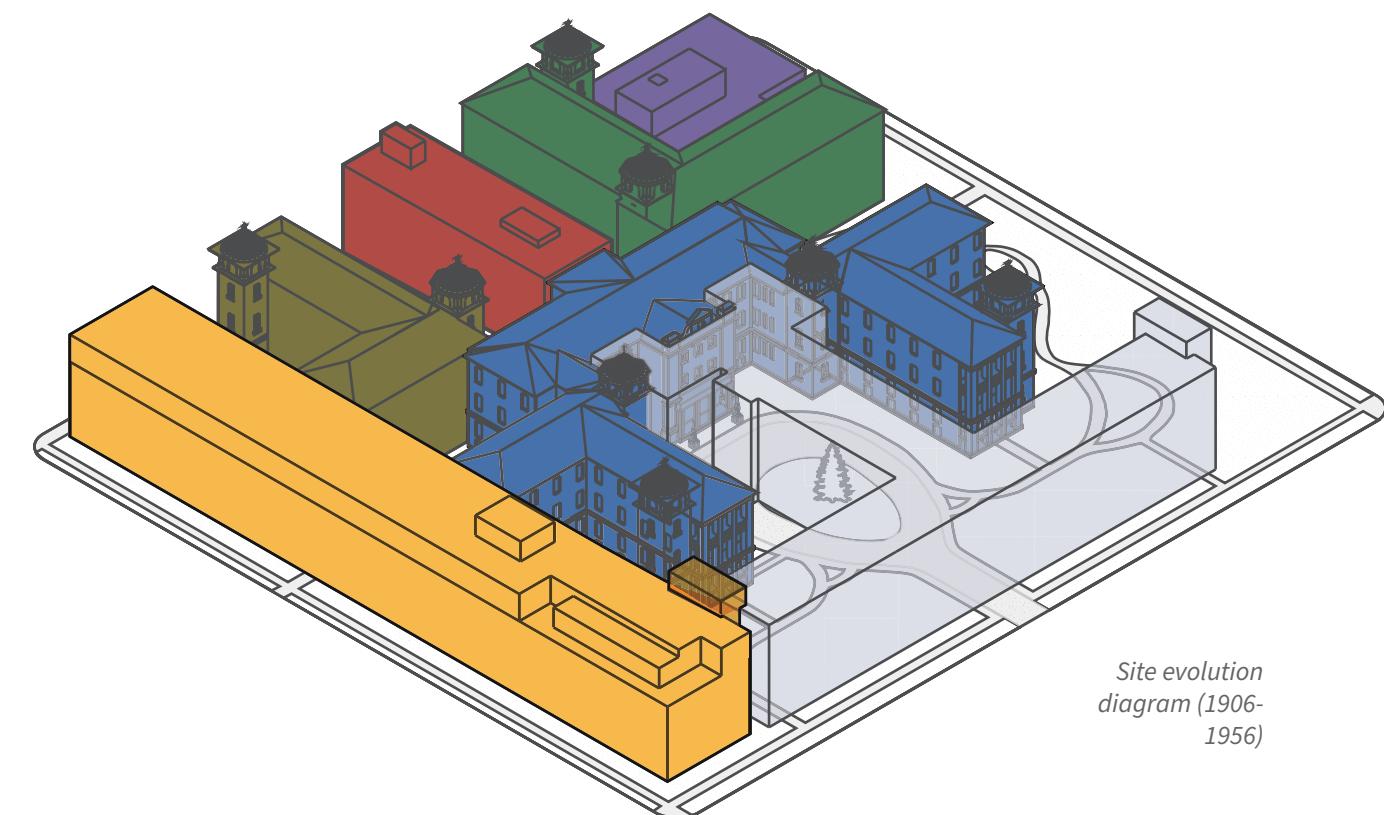
Since completion of the Heather Pavilion's original portions in 1906, successive additions were added to the building throughout the first half of the 20th century, to meet evolving needs. Early additions in 1908 and 1912 were generally sympathetic to the original building, continuing its "pavilion" form. Unsympathetic post-war additions largely obscured and overclad the original building fabric, most notably the 1951 "Chronic" wing (removed in early 2009) which infilled the landscaped forecourt.

Site evolution diagram (1906-1956)

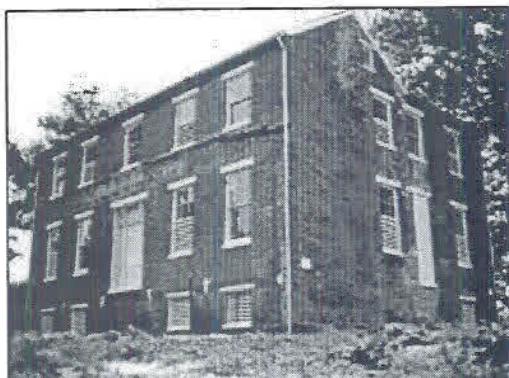
This building has been successfully mothballed for 10 years because the roof and walls were repaired and structurally stabilized, ventilation louvers added, and the property maintained. Photo: NPS files.

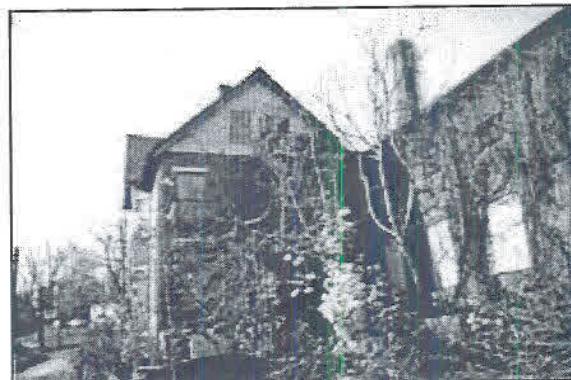
Boarding up without adequate ventilation and maintenance has accelerated deterioration of this property. Photo: NPS files.

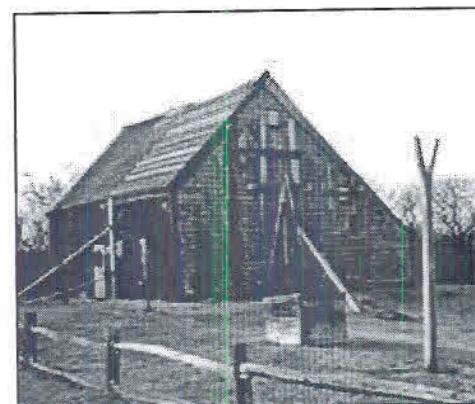
Buildings seriously damaged by storms or deterioration may need to be braced before architectural evaluations can be made. Photo: John Milner Architects. Photo: NPS files

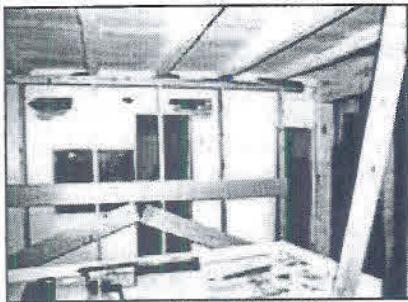
Interior bracing which will last the duration of the mothballing will protect weakened structural members. Photo: John Milner Architects.

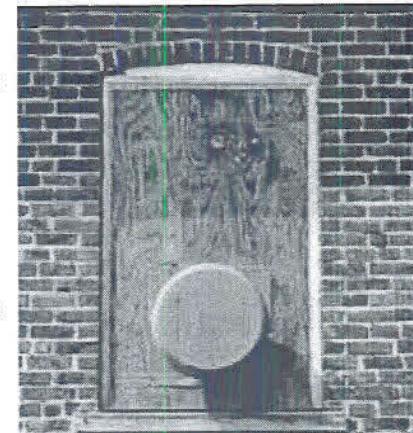
This exhaust fan has tamper-proof housing. Photo: Michael Mills, Ford Farewell Mills Gatsch, Architects.

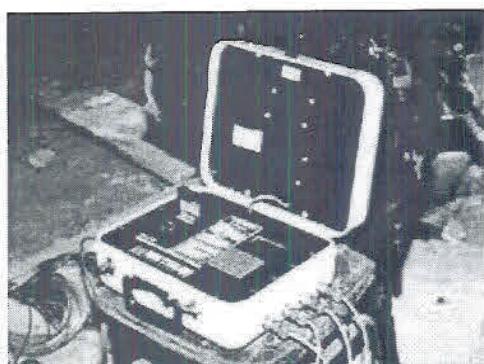
Portable monitors are used to record temperature and humidity conditions in historic buildings
