SERVICE BUILDING

800 GRANVILLE STREET, VANCOUVER, BC

CONSERVATION PLAN

OCTOBER 2022

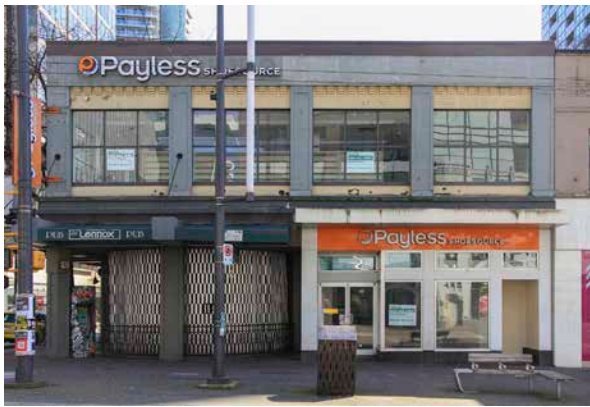
Above Top: Drawing of Granville Street façade of the Service Building from 1922 (Townley & Matheson, City of Vancouver Development and Building Services Centre). **Above Bottom:** View of the Granville Street façade as it appeared in July 2021. (Donald Luxton & Associates)

storefront and replacement of original assemblies modern metal assemblies. No elements of the original storefronts are present on the building.

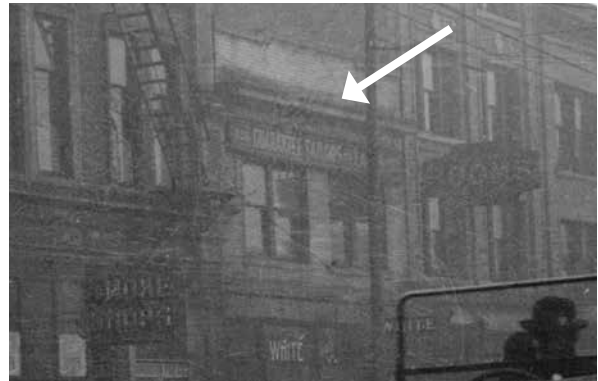
Historic view of original parapet with metal cornice as viewed from Granville Street, 1910s. [CVA Trans N87.08]

At the parapet level, a historic cornice was observed to be missing in its entirety. Archival drawings and photos indicate at the time of construction, a galvanized metal cornice was present and later altered between 1953 and 1959, before being removed in the 1990s. The exact date of the cornice was removed could not be determined.

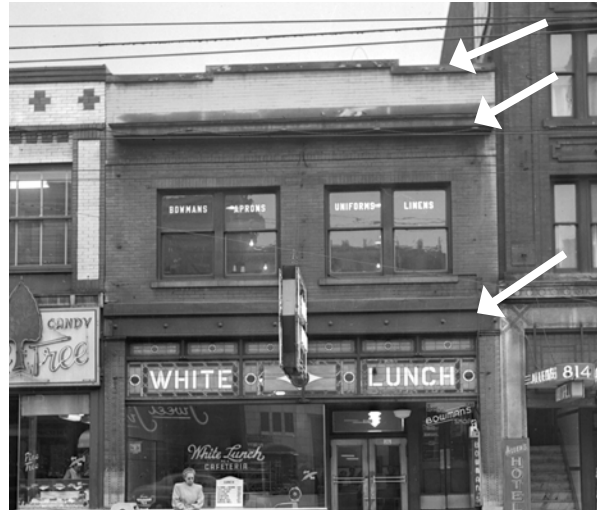
Historic view of original parapet with metal cornice and cap flashing as well as the original storefront cornice as viewed from Granville Street, 1950s. [VPL 81449]

The storefront level possessed a minimal metal cornice punctuated by bolts. Due to later interventions to the storefront, it is not known if any original elements of the storefront cornice remain.

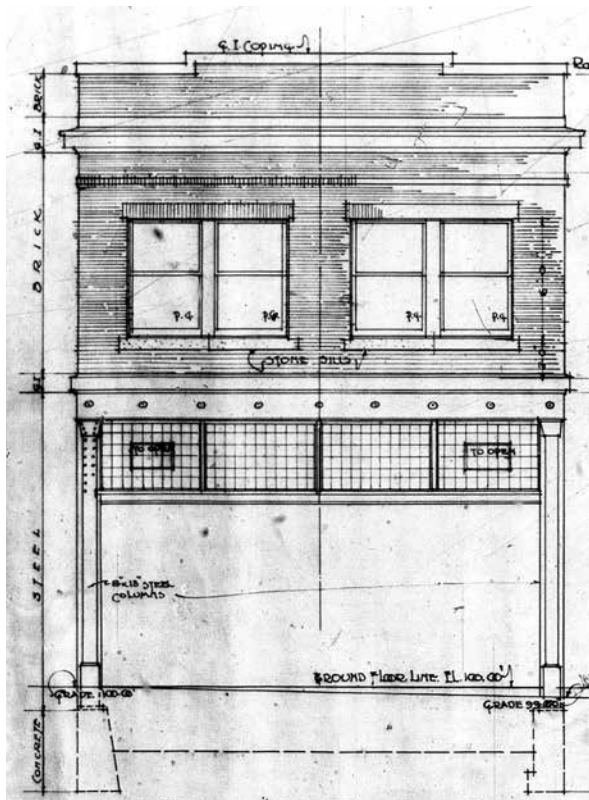
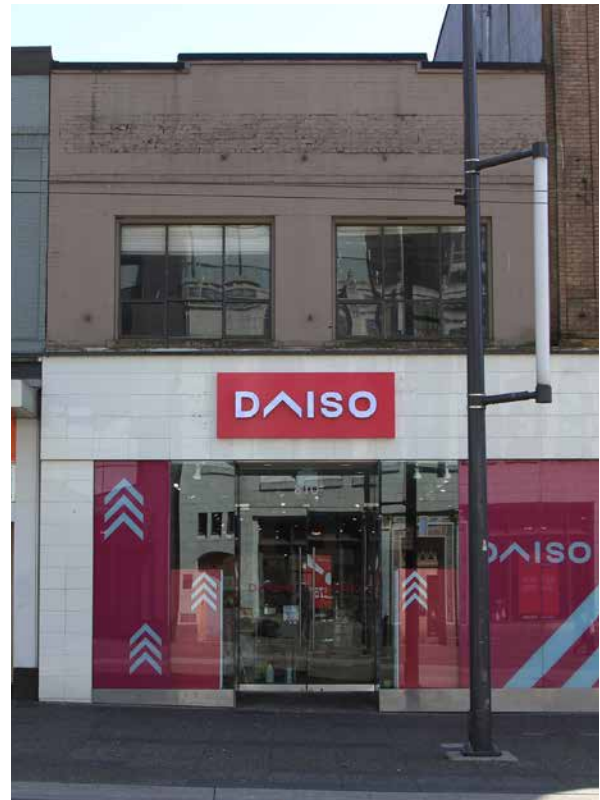
The Cameron Block features metal cap flashing which is not original to the building's construction. A galvanized metal cap flashing was installed at the time of construction, based on archival drawings and photo documentation.

Left: Granville Street elevation of the Cameron Block from 1912 (Parr, Mackenzie and Day, City of Vancouver Development and Building Services Centre); **Right:** View of Granville Street facade as it appeared in March 2021. (Donald Luxton & Associates)

- Evaluate the overall condition of the parapet cap flashing to determine whether more protection, maintenance and limited repair or replacement in kind is required.
- Remove corrosion that may be discovered upon close inspection, patch and repair, caulk joints as required and apply appropriate primer for galvanized surface.
- Repair or replace deteriorated flashing, as required. Repairs should be physically and visually compatible.
- If new flashings are installed, ensure that the colour is compatible with the overall colour scheme.

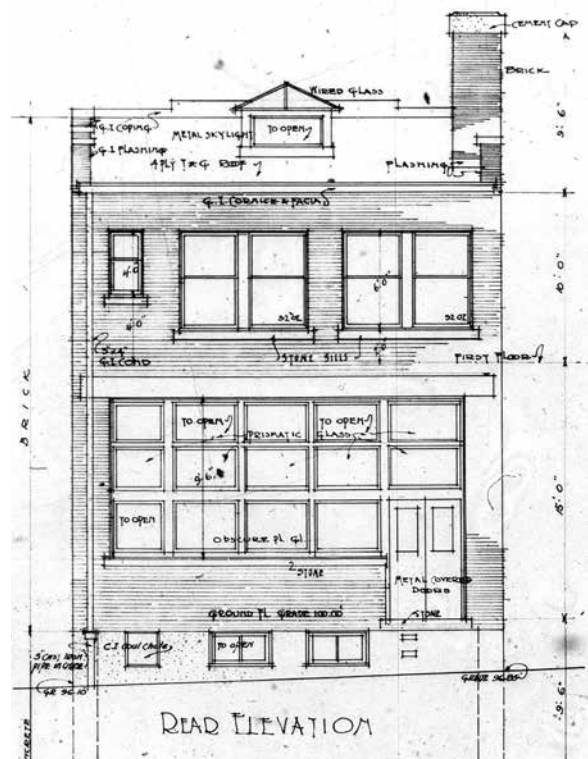
At the rear façade, all the original windows have been re-configured and blocked with concrete. The date of this intervention could not be determined. As part of the redevelopment scheme, the rear and side façades and support structure will be removed to facilitate the construction of an underground parkade and modern multi-storey addition behind and above the retained Granville Street façade.

Opposite Top: Rear view of side wall from alley street as it appeared in March 2021. (Donald Luxton & Associates) **Opposite Bottom:** Rear façade elevation. (Donald Luxton & Associates) **Above Right:** Rear façade elevation from 1912. (Parr, Mackenzie and Day, City of Vancouver Development and Building Services Centre)

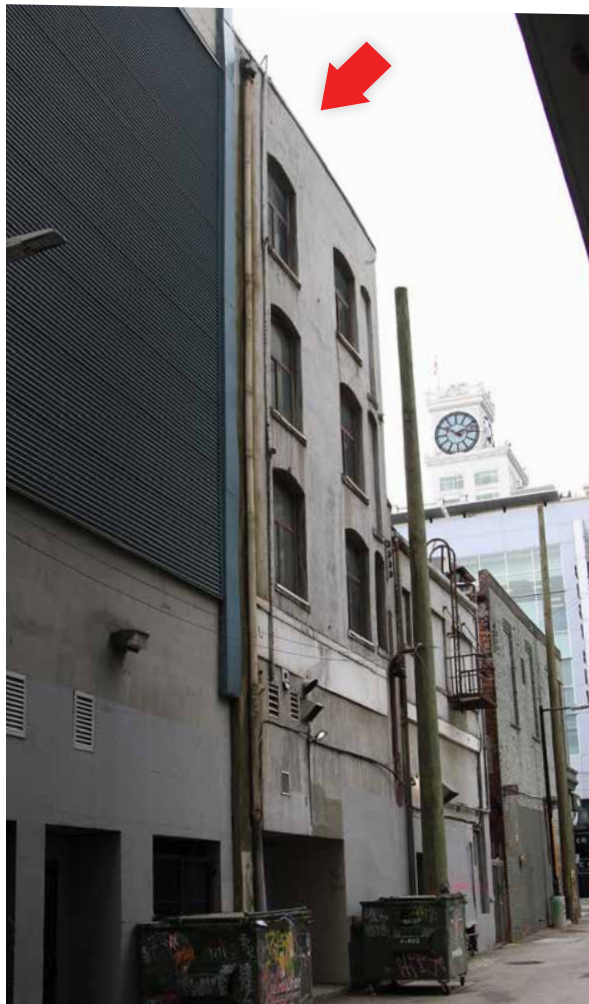
View of the rear façade of the Allen Rooms, July 2021. (Donald Luxton & Associates)

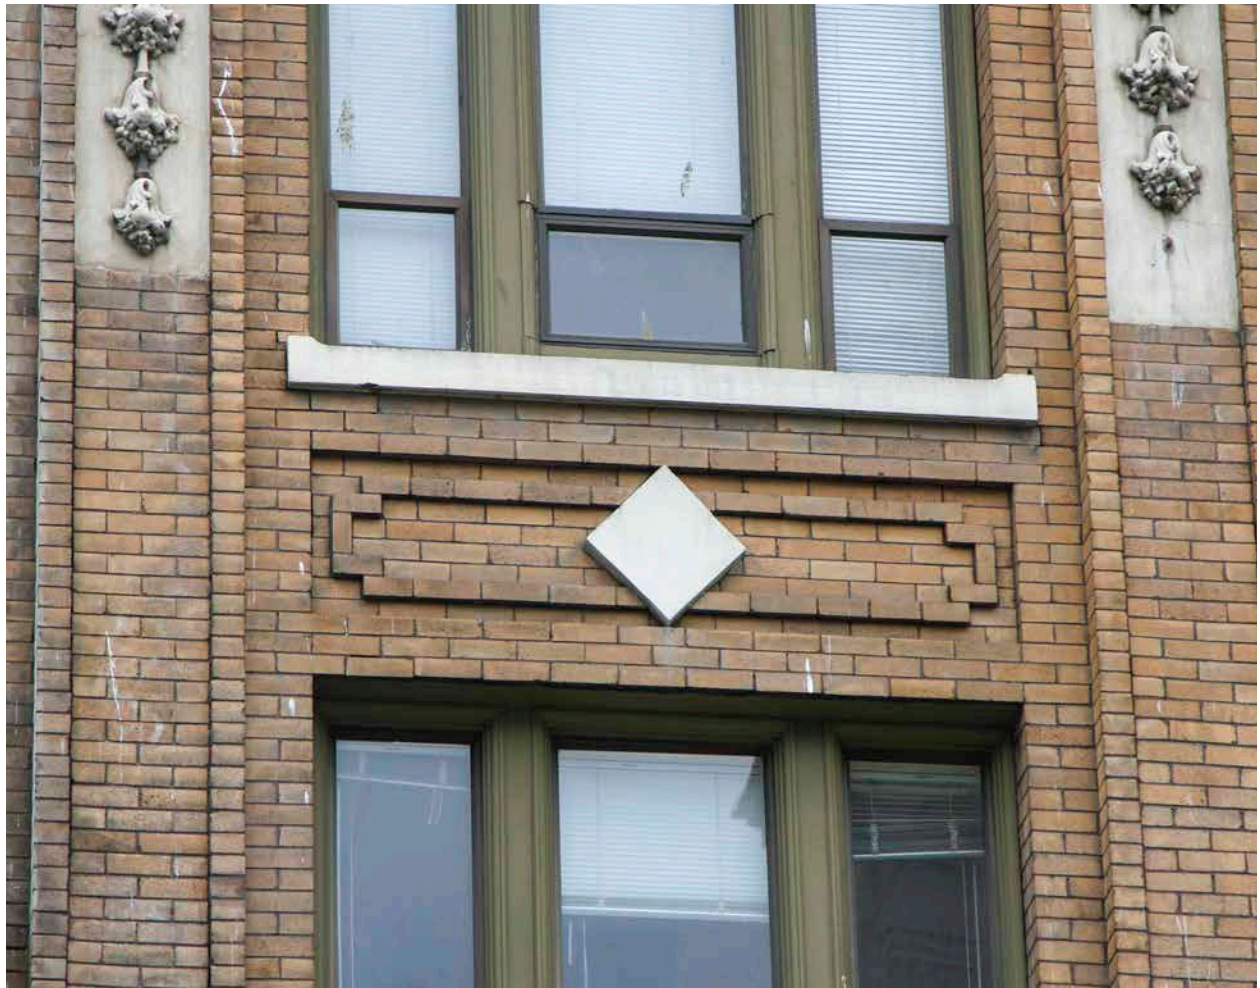
The Granville Street façade of the Allen Rooms is clad in light brown coloured brick laid in running bond with medium grey coloured mortar. The façade features four spandrel panels with decorative brick borders and precast concrete diamond shape shield. The façade also features pilasters with precast ornamental panels which were observed to be in fair condition. The ornamental panels each include four cascading cornucopias are connected. One cornucopia is missing from the middle pilaster. All missing or severely deteriorated character-defining elements of the retained front façade should be restored based on documentary and

Front façade showing brown-coloured brick in running bond and brick-bordered end pilaster. Spandrel panels feature decorative borders, and ornamental precast concrete rhombus in the center with matching concrete window sills above. (Donald Luxton & Associates)

- Preserve and restore the historic brick front façade along Granville Street, including the restoration of the altered masonry parapet;
- Restore missing or severely deteriorated

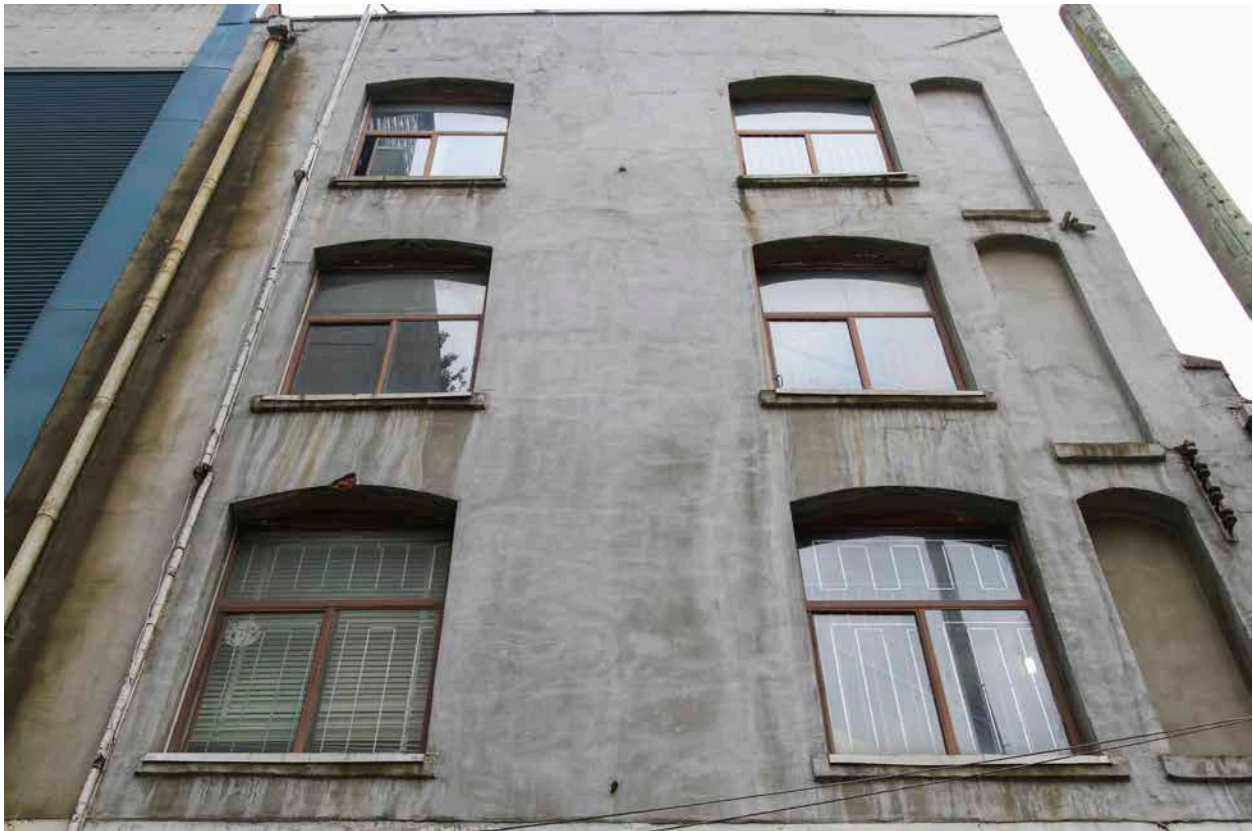
View of the rear façade of the Allen Rooms with brick structure covered in a rendered. (Donald Luxton & Associates)

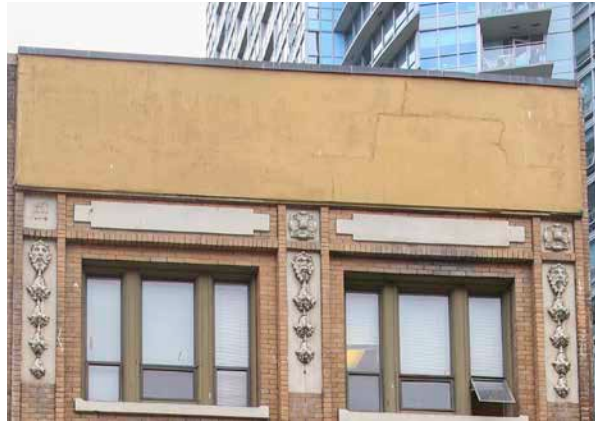
Based on available archival documents, when completed the front façade possessed galvanized iron cornices at the storefront and parapet levels. Both cornices have since been removed from the front façade. Archival photographs indicate, interventions to the original cornices began in 1949. Further investigation is required to verify the composition and design of the original cornices to determine if any elements remain hidden behind later interventions. Archival drawings also suggest

Parapet with missing cornice since c.1949. Currently the parapet features a solid cement render finish with signs of staining, cracking, and paint peeling. (Donald Luxton & Associates)

When first constructed, the centre of the parapet of the front façade possessed a large arched cast panel comprised of multiple scrolled festoon elements. The cast panel, metal cornice, and masonry parapet, were removed c.1949. These elements are to be restored using available archival images and drawings as part of the overall conservation of the Allen Rooms' front façade.

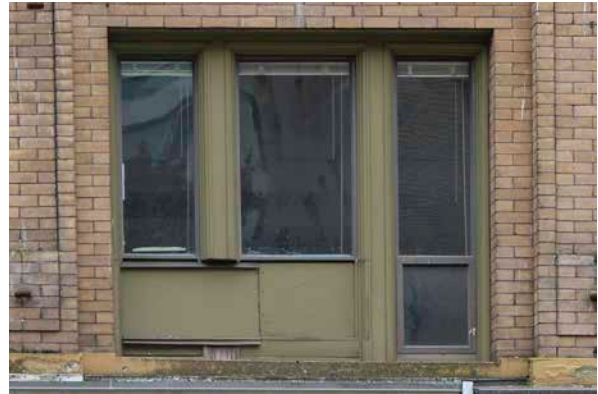
Front façade window with original wood frame and mullions, but with non-original sashes and glazing. Portion of mullion has been removed, and two lower sashes are boarded over. (Donald Luxton & Associates)

replacements. The original wood windows of the front façade consisted of one-over-one hung wood windows. The extant original wood elements of the front façade windows that remain are in generally good condition, with localized areas of paint failure. Two windows on the second floor are partially boarded which has impacted the original frames and mullions.

The front façade windows are proposed to be preserved with the historic façade retention as part of the redevelopment scheme. Original wood elements such as frames and mullions will be preserved and wood window sashes restored based on archival documents. Further investigation is required to determine the extent of repairs required for intact original wood elements.

- Preserve the original window openings, wood window frames, and wood mullions of the Granville Street façade.
- Complete a detailed window assessment and inventory to determine extent of recommended replacement at the historic front façade.
- Restore missing or replaced sashes with new wood sashes based on physical and documentary evidence.
- Prime and repaint as required in appropriate colour, based on colour schedule devised by Heritage Consultant.

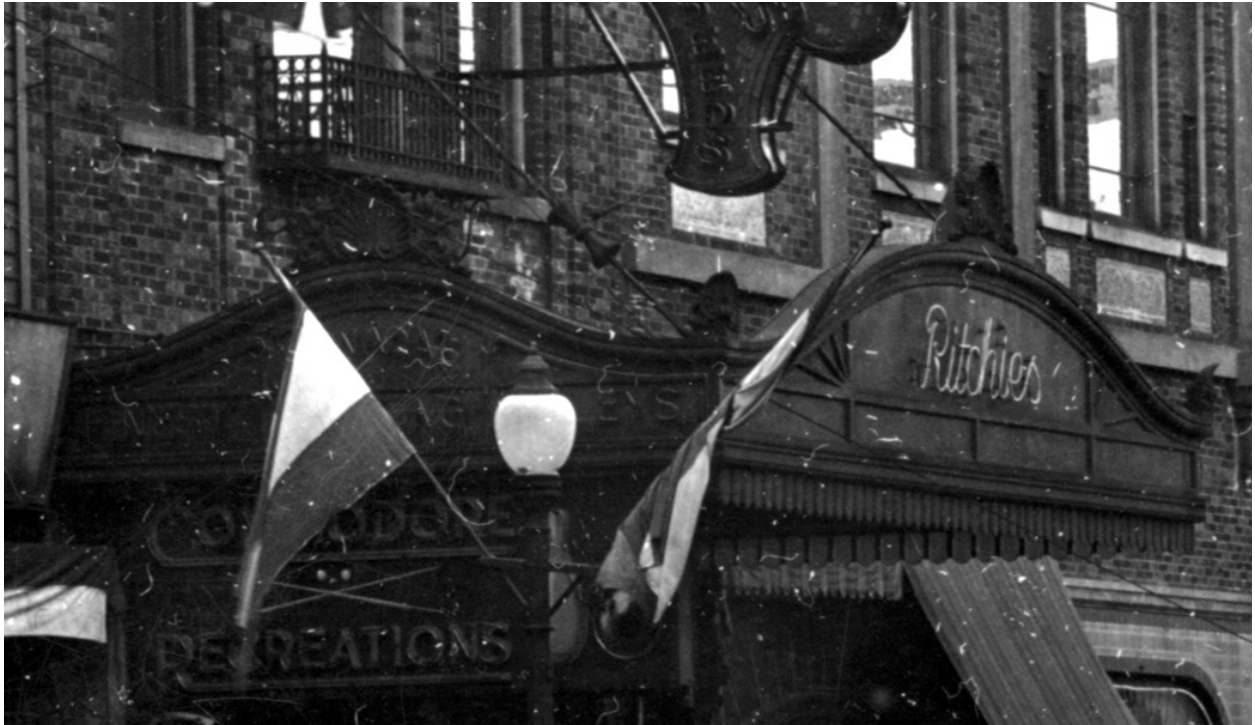
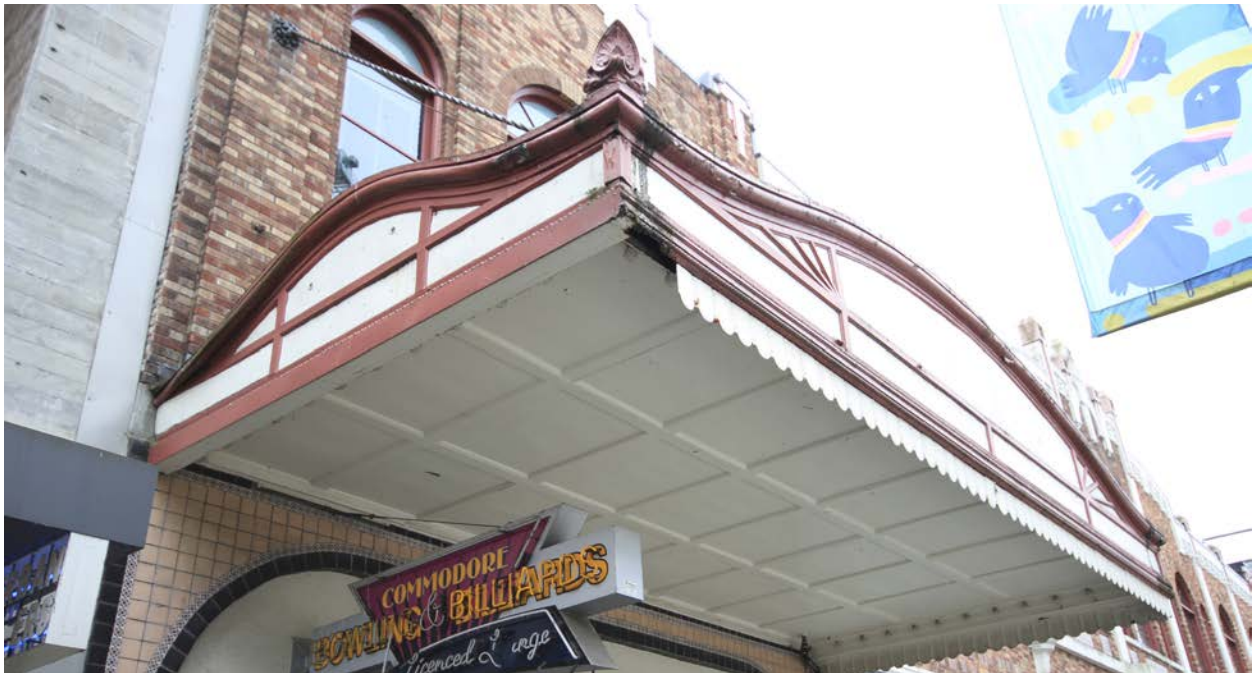
The Commodore Ballroom also retains its original metal balustrade at the second floor window of the north structural bay. Viewed from the street, the balustrade appears to be in fair condition with corrosion and paint failure evident. The anchoring of the balustrade wasn't assessed as part of the review.

At some point after the Commodore Ballroom was completed, a metal cap flashing has been installed on sections of the parapet. The cap flashing was likely installed to protect the cap of the parapet where the parging may have failed in the past. The front façade also possesses redundant metal anchors that previously supported storefront canopies and signage.

Above: Cantilevered canopy at the north end of the Commodore Ballroom with sign for basement level recreations evident (VPL 11037).

Below: Extant canopy at north end of the Commodore Ballroom with missing cresting elements and portion of detailing below the canopy missing. Corrosion and staining is also evident at corners of canopy.

As part of the redevelopment scheme, the existing metalwork of the front façade will be retained. It is recommended that corroded metalwork be addressed and the anchoring of the balustrade and canopies be assessed by a Structural Engineer. If interventions to the canopies and balustrade are required, they should be done in a manner that retains original materials that are in good or repairable condition. Repairs and improved anchoring should not be readily evident or change the detailing and appearance of these elements.

- Preserve existing metalwork of the front façade of the Commodore Ballroom.
- Evaluate the overall condition of the metalwork to determine whether more than protection, maintenance and limited repair or replacement in kind is required.

- The current attachment of all metalwork should be inspected, and should be re-anchored as appropriate.
- Repair and stabilize deteriorated architectural metal elements by structural reinforcement or correction of unsafe conditions, as required, until any additional work is undertaken. Repairs should be physically and visually compatible.

- Remove corrosion that may be discovered upon close inspection, patch and repair, caulk joints as required.
- The metalwork should be cleaned and prepared for repainting. Apply appropriate primer for galvanized surfaces. Paint in historically appropriate colour, based on colour schedule prepared by Heritage Consultant.

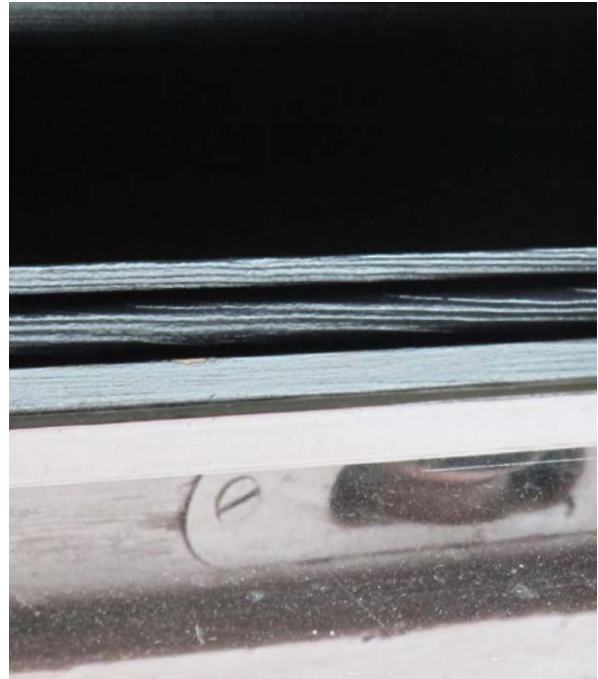
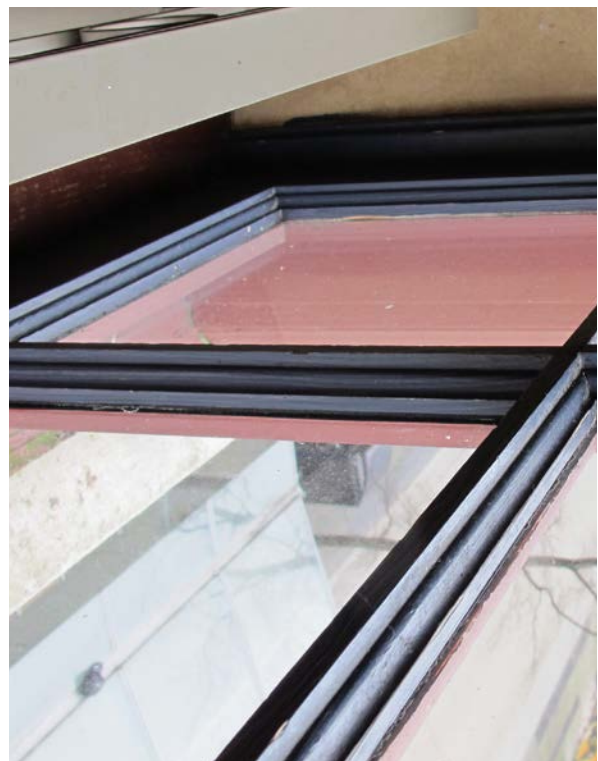
The second floor of the Granville Street façade of the Commodore Ballroom retains its original window openings and components of its original wood window assemblies. The façade possesses arched windows of single and triple assembly with multi-lite sashes. When completed, the arched multi-lite transoms of the larger windows operated as a hopper-style window. The lower windows of the smaller arched single-lite transom operated as a double hung window. The windows of the second floor are presently fixed and some of the sashes have been replaced. The original 1-over-1 sashes of the windows with the single-lite transom have been replaced with a fixed two-lite sash that matches the general appearance of the original. Many of the arched transoms retain their original glazing. Overall, the windows of the front façade are in good condition with localized paint failure and sill deterioration.

*Top: Original sash spool of second floor double hung window. Hung windows were changed to two-lite fixed sash.
Bottom: Original multi-lite wood sash window from interior.*

- Inspect for condition and complete detailed inventory to determine extent of recommended repair or replacement.
- Retain existing window sashes; repair as required; install replacement matching sashes where missing or extensively altered and beyond repair.
- Each window should be weather tight.

- Replace damaged glazing.
- Remove later interventions to windows, if possible, and restore to match original.
- Prime and repaint as required in appropriate colour, based on colour schedule devised by Heritage Consultant.

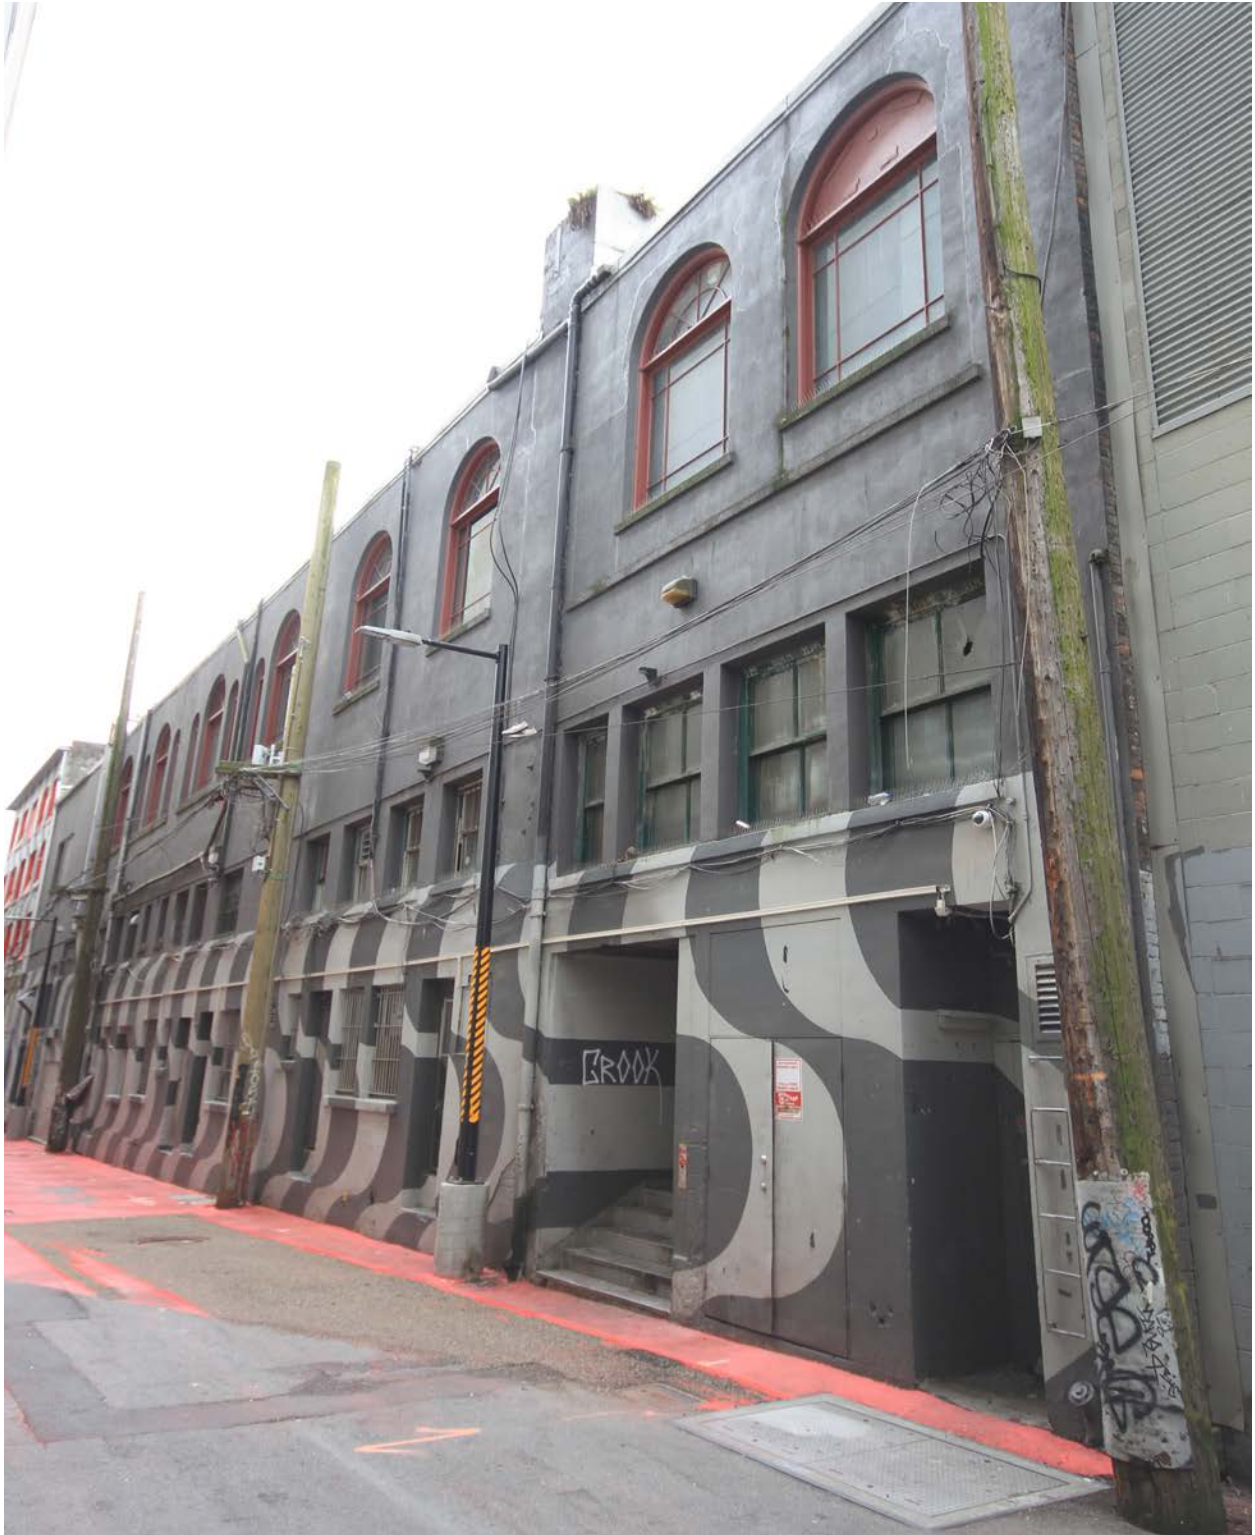
The rear façade of the Commodore Ballroom features a variety of window openings and assemblies. The style, configuration and patterning of the windows of the second floor of the rear façade are similar to those present on the Granville Street façade. Single and triple assembly windows with multi-lite transoms and sashes are present on the rear façade; however some sashes have been altered. The mezzanine and ground floor windows of the building are metal hung windows with corrosion, efflorescence, broken glass, and paint failure present. A number of changes have been made to the mezzanine and ground floor windows since the building’s completion such as: louvres installed in some

Window fenestration and recessed entries of the rear façade of the Commodore Ballroom.

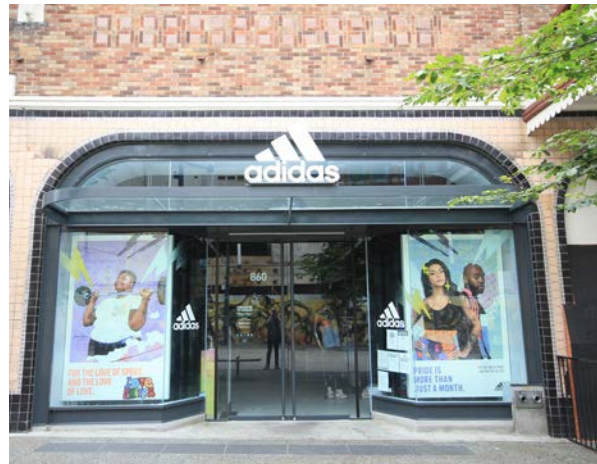
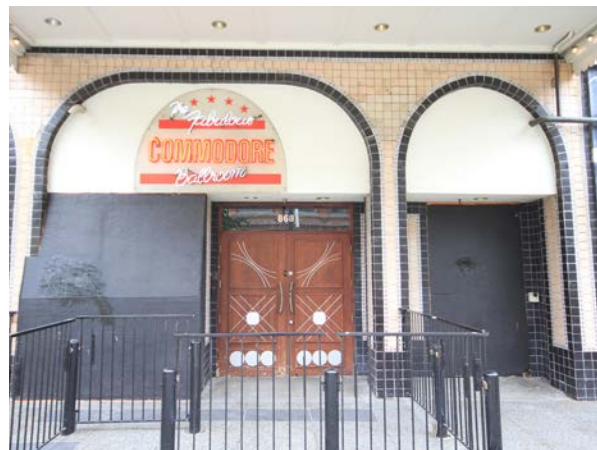
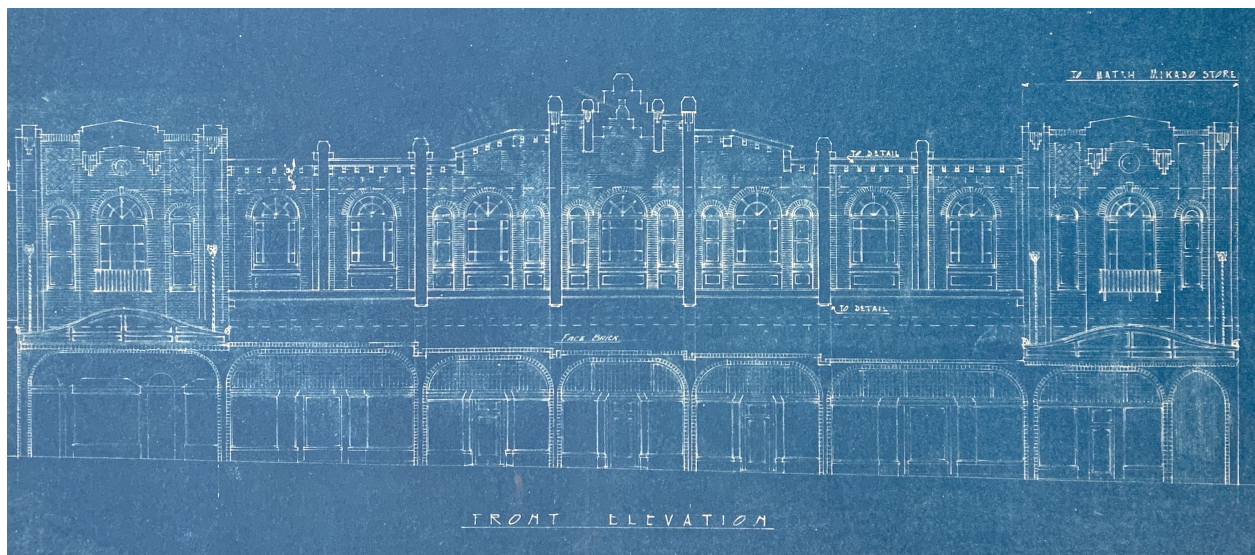
Top: Typical storefront with original arched opening and tile work preserve and new storefront assembly.
Middle: Entry and box office (boarded over) to second floor at left and entry to former restaurant on the right. Originally the Commodore Ballroom was accessed through the entry on the right.
Above: Archival drawing of front façade of Commodore Ballroom.
[CVA COV-5393-1, AP-533]

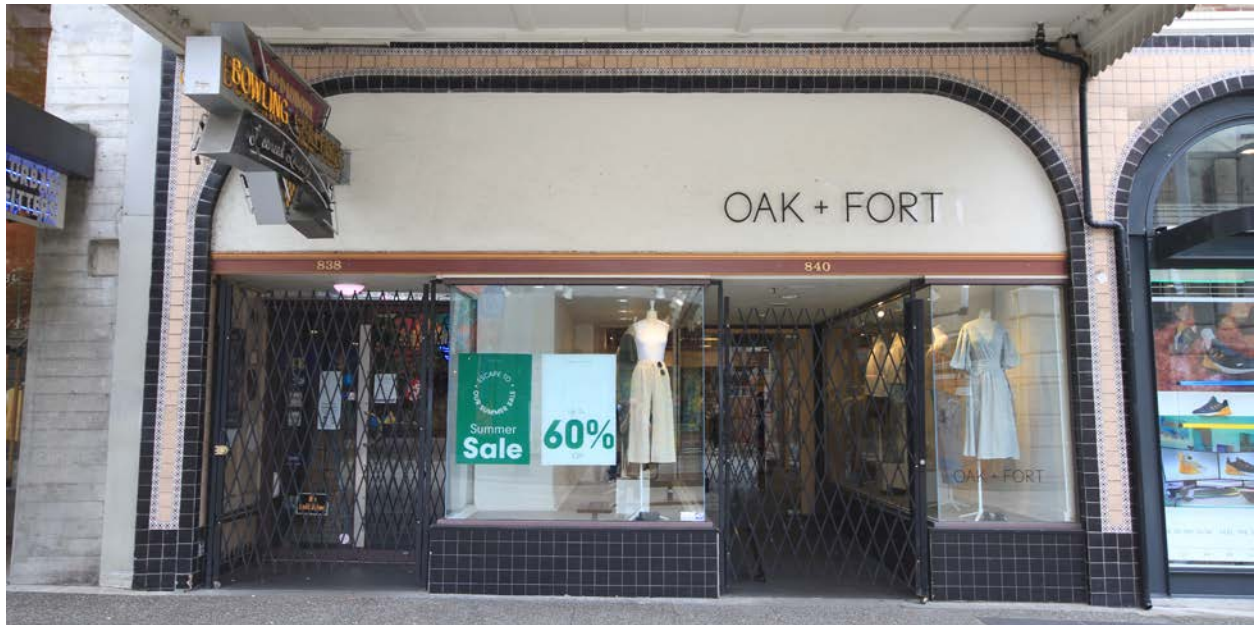
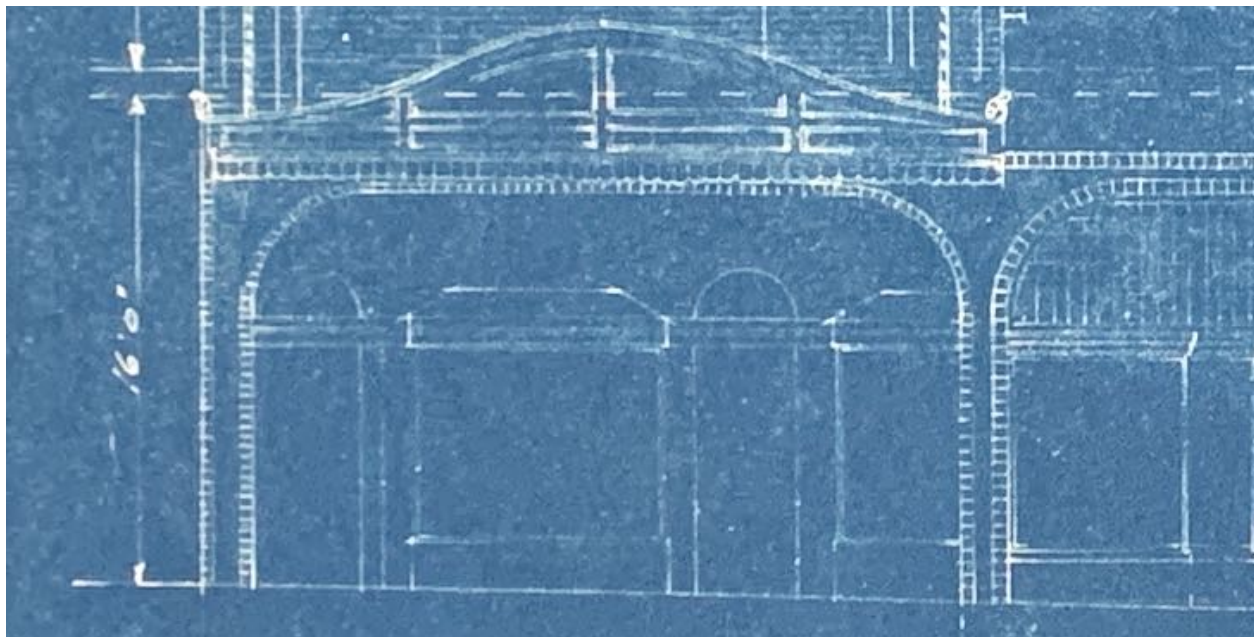
Above: Existing storefront of northern most structural bay with entry to basement level at left.
Below: Northern structural bay storefront suggesting location of storefront and bulkhead below glazing reflects original.

the storefronts have been altered from their original. A possible exception is the northern most storefront which, based on archival drawings, appears to retain its original storefront design; however the assemblies have been changed. When first constructed the storefront transoms were a glazed fan light design.

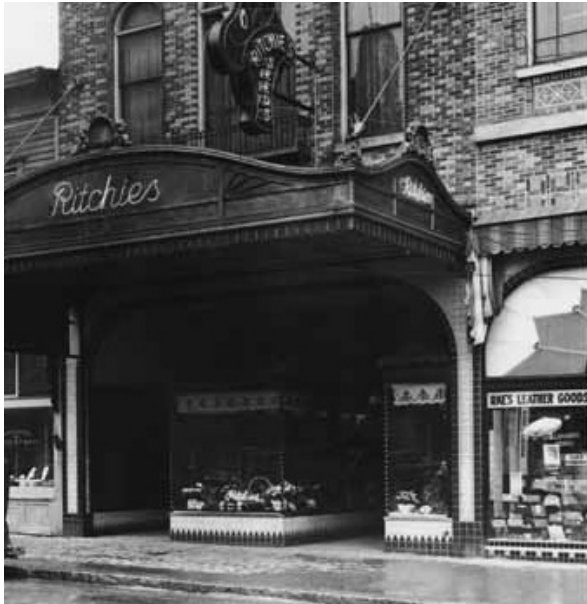
Northern most storefront with original canopy. Note adjacent storefront design and materials including original fan light transom, 1931 (1931. Thomson, S. VPL 9007)

What as constructed also differed from what is shown on the architectural drawings. The original fan-lite transoms have been replaced with the modernizing of the storefront design and assemblies.

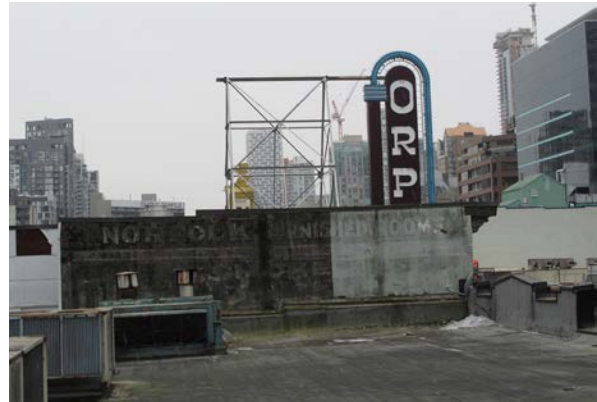
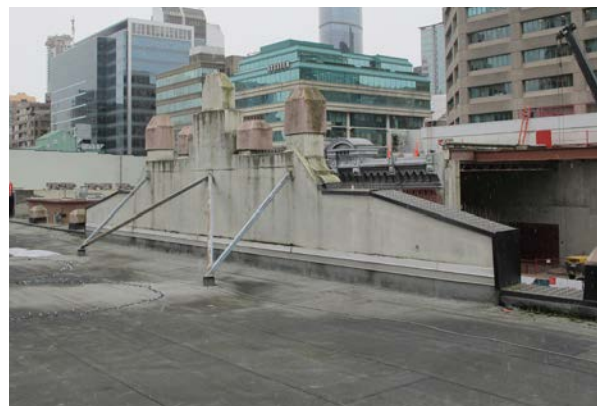
Top and Above: Existing assembly and condition of the Commodore Ballroom's roof.

present on the roof. Overall, the existing roof appears to be in good condition with no pooling water noted.

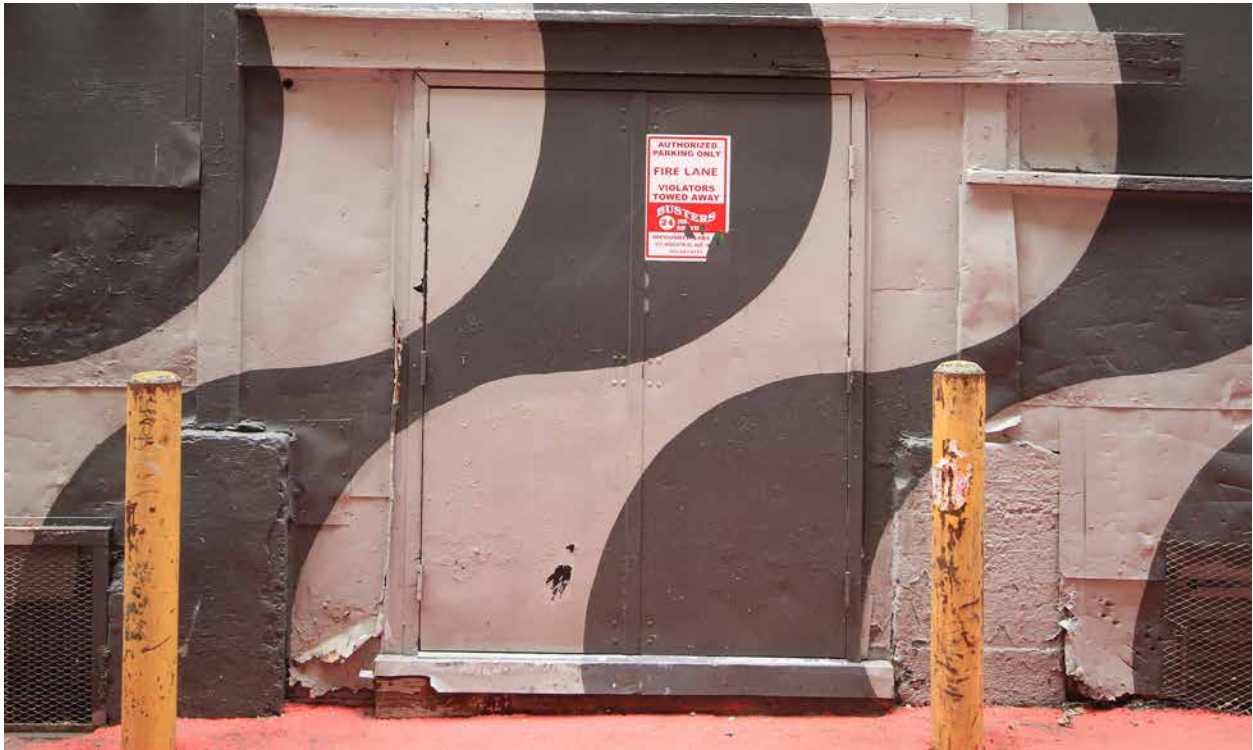
The foundation of the Norfolk Rooms was not examined by the Heritage Consultant and its composition and condition are unknown. Archival documents available indicate that the foundation structure is composed of reinforced concrete. The extant exterior concrete and masonry walls extend to grade, which aspects having changed over time at both front and rear façades.

Rear façade of Norfolk Rooms showing portions of the building concrete foundation, July 2021. (Donald Luxton & Associates)

- Foundations should be reviewed by a Structural Engineer. Once condition is assessed, revised conservation strategies can be recommended if required.
- Existing foundations should be preserved, if possible.
- If new foundations are proposed, concrete is a suitable material. New material should match original in appearance, as viewed from the exterior.
- To ensure the prolonged preservation of the new foundations through adequate site drainage.

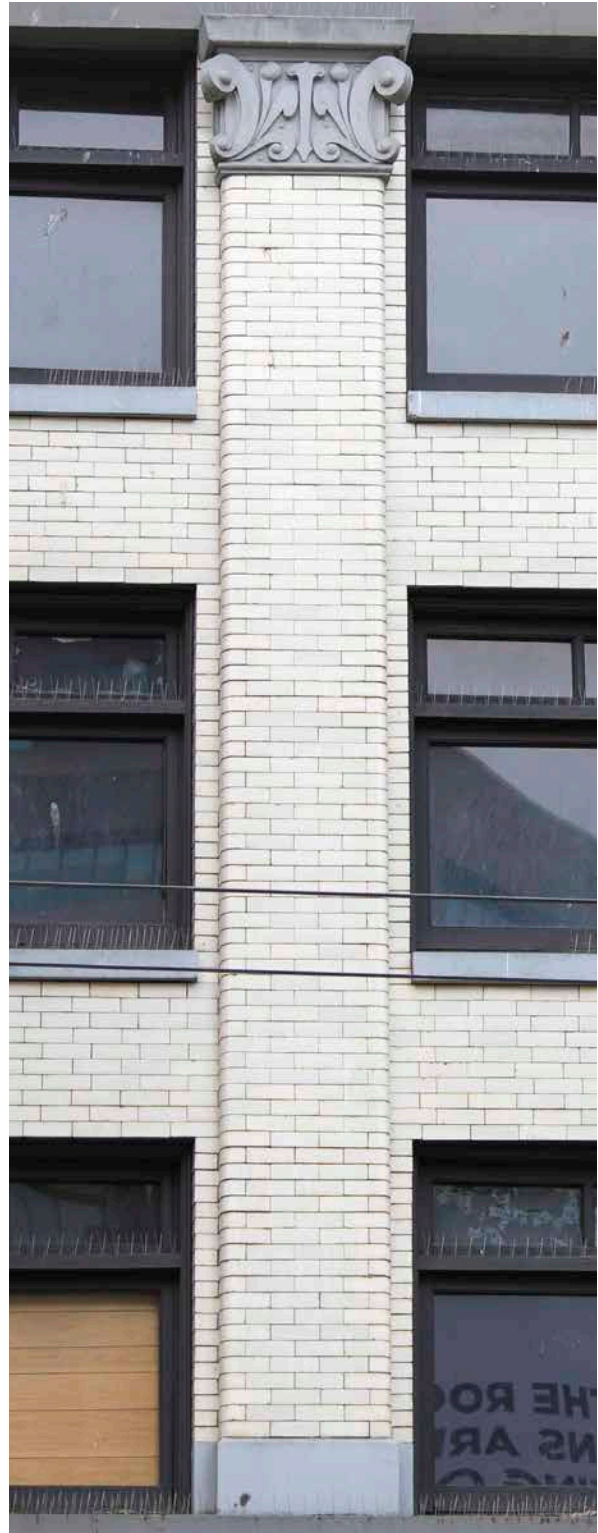
The building's front façade's glazed brick shows varying degrees of weathering and deterioration. Closer inspection of the glazed bricks reveal sections that have suffered mortar loss, chipping, flaking, and a collection of redundant anchoring and holes drilled through the glazed bricks likely associated with past signage and canopies. Most notable of the redundant anchors, two decorative metal eye bolts which remain imbedded in the brick façade and are vestiges of a historic metal canopy. Numerous patched holes are also visible on the surface of the brick which affected the overall appearance of the glazed brick front façade.

Glazed white brick on the front façade of the Norfolk Rooms showing the bullnose cornering of the pilasters, July 2021. (Donald Luxton & Associates)

- Undertake complete survey of the condition of all exterior masonry surfaces.
- Cleaning of the masonry using gentlest means possible. Only approved chemical restoration

cleaners may be used. Sandblasting or any other abrasive cleaning method of any kind is not permitted. All cleaning treatments will be reviewed by the Heritage Consultant prior to being used on site. Mock up of cleaning required.

- Preserve sound exterior masonry brickwork whenever possible, and replace in-kind brick which is too deteriorated for continued use.
- All redundant metal inserts and services mounted on the exterior walls should be removed or reconfigured.
- Preserve all original decorative metal inserts anchors.
- Any holes in the brick should be filled with repair mortar or brick replaced using brick matching original.
- Repoint deteriorated mortar joints. Take care that the arises of the brick are not damaged. Work should only be undertaken by skilled masons. Do not use power tools to cut or grind joints unless contractor can demonstrate brick will not be damaged during cutting of joints through mock-up. Repoint mortar joints with new mortar that matches existing in consistency, composition, strength, colour and pointing profile.

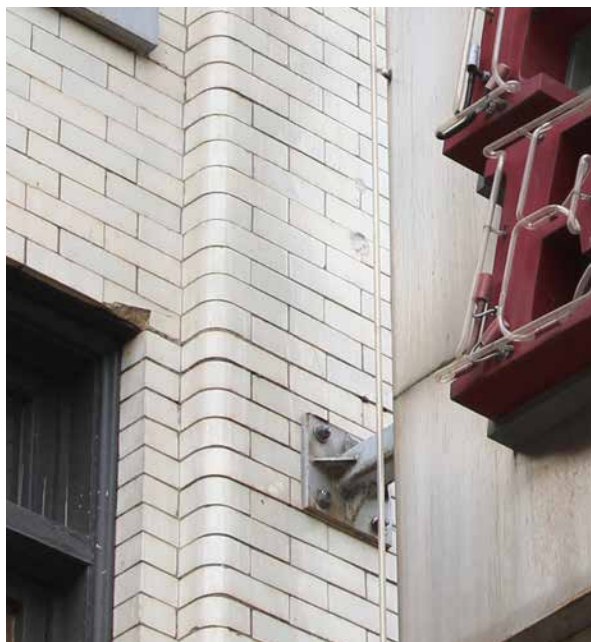
Damage, discolouration, and past patching visible on the face brick of the front façade, July 2021. (Donald Luxton & Associates)

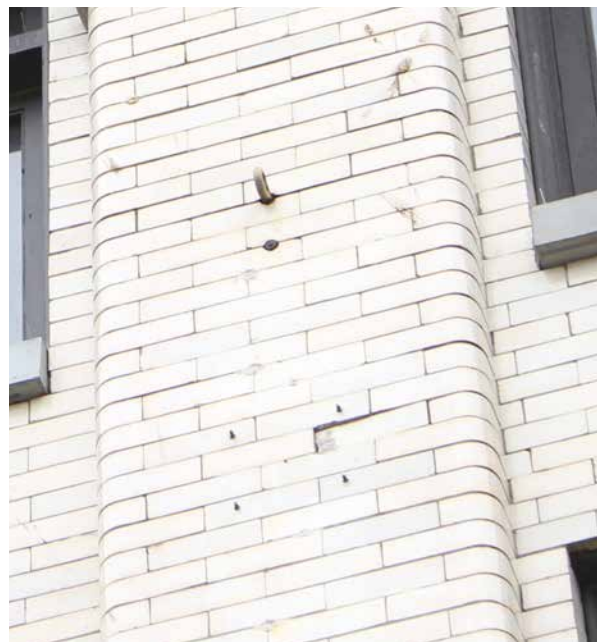
Redundant anchors still installed into brick faces and mortar joints of the front façade, July 2021. (Donald Luxton & Associates)

- Masonry specifications to be reviewed by Heritage Consultant.
- All future seismic anchoring should be reviewed with the Heritage Consultant and carried out in a manner that minimizes damage to the glazed bricks.

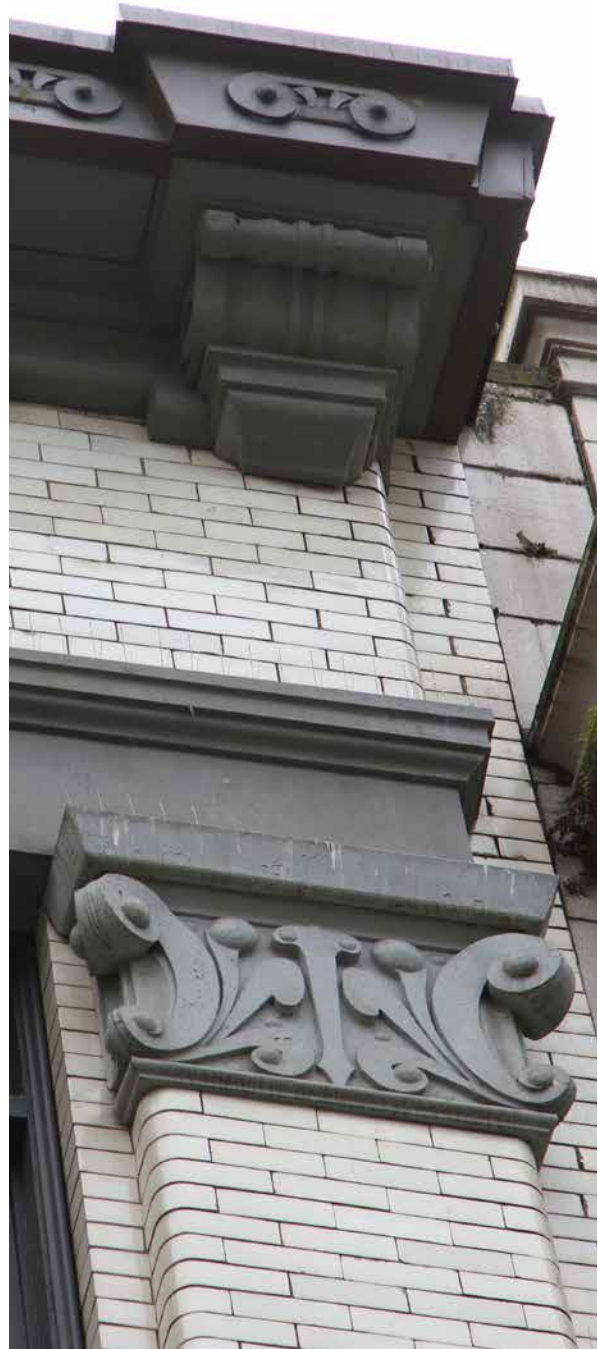
An existing painted storefront level cornice spanning the whole length at the building provides a distinct separation from the floors above and the storefront level. The cornice is simple in its detailing. Noticeable paint deterioration with flaking due to weathering and exposure are evident. The storefront cornice is not original; however the sill band above is original and intact.

Detail of the Corinthian capital; lintel band; and cornice of the Norfolk Rooms, July 2021. (Donald Luxton & Associates)

As part of the redevelopment, all extant decorative metalwork on the front façade shall be preserved and repaired. Missing elements such as the storefront cornice will be restored to their original construction design where possible using available archival documents as guides.
