SERVICE BUILDING

800 GRANVILLE STREET, VANCOUVER, BC

CONSERVATION PLAN

OCTOBER 2022

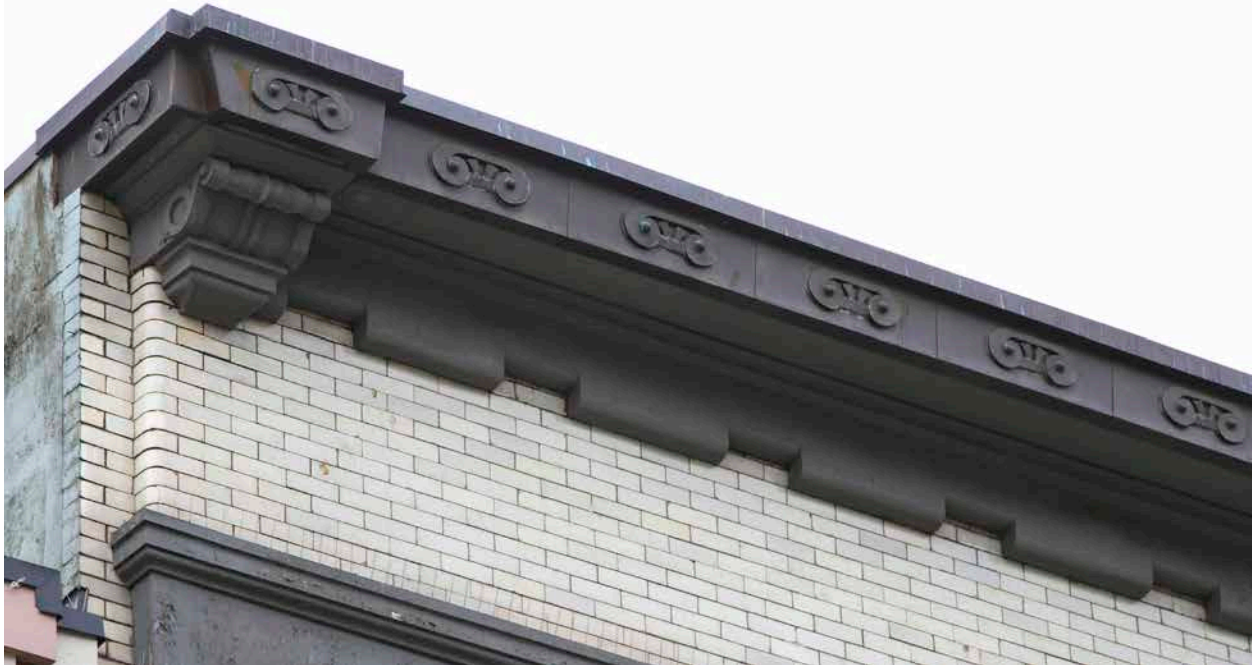
Detail of the parapet cornice along the front façade of the Norfolk Rooms, July 2021. (Donald Luxton & Associates)

- Verify the composition of the decorative elements to determine the appropriate approach to their conservation.
- Evaluate the overall condition of the metal cornice to determine whether more than protection, maintenance and limited repair or replacement in kind is required.

- The current attachment of all metalwork should be inspected, and should be re-anchored as appropriate.
- Repair and stabilize deteriorated architectural decorative elements by structural reinforcement or correction of unsafe conditions, as required, until any additional work is undertaken. Repairs should be physically and visually compatible.

- If decorative element is made of metal, remove corrosion that may be discovered upon close inspection, patch and repair, caulk joints as required.
- If an evaluation of the upper cornice reveals components too deteriorated to repair, remove and replace with new that match the original.

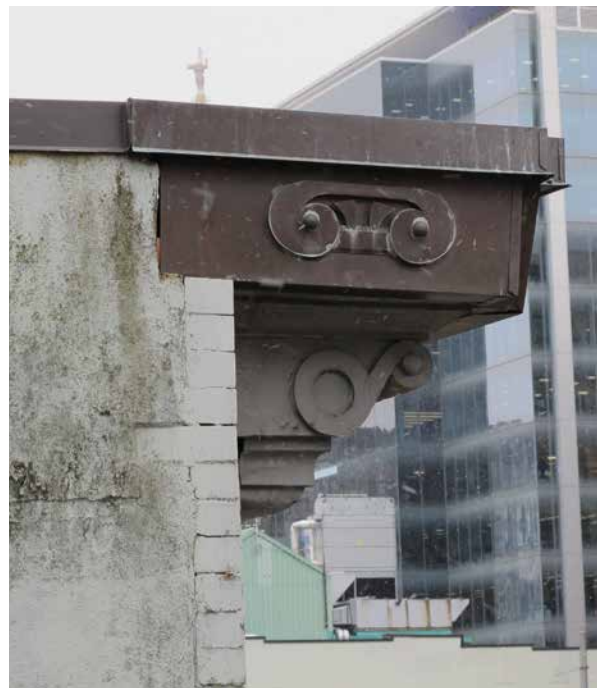
Detail of the cap flashing on the parapet and cornice of the Norfolk Rooms, July 2021. (Donald Luxton & Associates)

A metal cap flashing has been installed at the parapet level. A detailed review was not possible at the time of the site visit as building access was not available. However, when viewed from the adjacent building's roof deck, no loose segments of the flashing were evident and the joints did not appear to have gaps or buckles. Some sections of the metal cap flashing appear to be corroded in areas. The cap flashing present on the parapet flashing is in fair to good condition. There are no missing or significantly damaged sections.

As the intent of the redevelopment is to retain the front façade, an evaluation on the current condition of the front façade's parapet flashing and its repair should be assessed when access is possible.

- Evaluate the overall condition of the parapet cap flashing to determine whether more than protection, maintenance and limited repair or replacement in kind is required.
- Remove corrosion that may be discovered upon close inspection, patch and repair, caulk joints as required and apply appropriate primer for galvanized surface.
- Repair or replace deteriorated flashing, as required. Repairs should be physically and visually compatible.

- If new flashings are installed, ensure that the colour is compatible with the overall colour scheme.

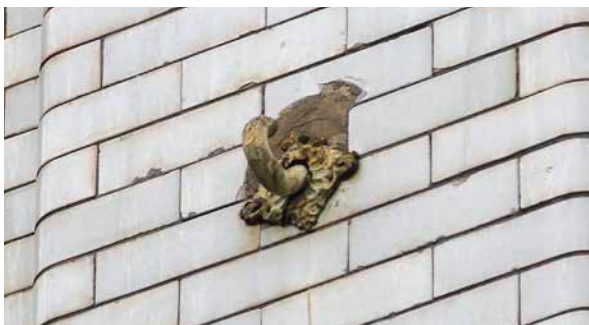
Detail of one of two decorative anchors installed in 1924 to support the Commodore Cafe marquee, July 2021. (Donald Luxton & Associates)

Available archival images show a lighted marquee that projected from the west end of the building above the storefront which was tied back to the façade with cables attached to decorative metal hook anchors. Typically found in the Granville Street historic district, marquees were used to advertise business, events, and promotions as well as provide shelter and street lighting. In addition to the marquee, blade signs were also installed on the Norfolk Rooms front façade resulting in the redundant anchors, damaged and patched bricks present today.

- Preserve the two cast iron anchors.
- Evaluate the overall condition of cast iron anchors to determine whether more than protection, maintenance and limited repair or replacement in kind is required.
- Remove corrosion that may be discovered upon close inspection, and remove paint using the gentlest method possible. Be mindful not to damage adjacent features during paint removal. Be aware of the risk of existing lead paint, which is a hazardous material.

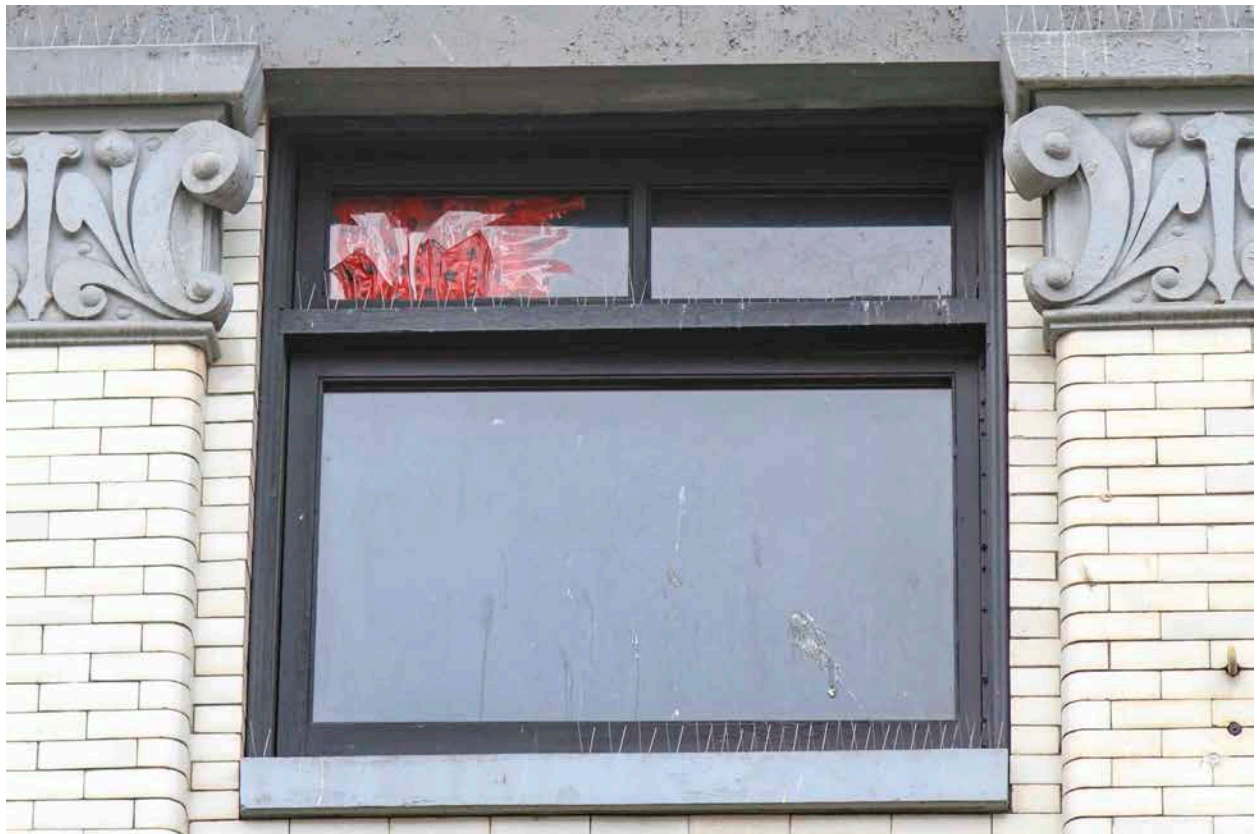
Detail of a typical, original wood window assembly on the front elevation of the Norfolk Rooms, July 2021. The single-lite sash is operable, featuring a vertical central pivot mechanism. (Donald Luxton & Associates)

The Norfolk Rooms front façade facing Granville Street is punctuated with a grid arrangement of pivoting, plate glass windows on the three levels above the storefront. The wood window assemblies are original to the construction of the building. A street level review was done to assess the existing conditions of the front façade windows. Various levels of deterioration were noted with warping, rot, paint cracking/peeling, and damaged glazing evident on some windows.

All original wood window assemblies of the front façade including frames, sashes and trim along with should be preserved and repaired in-kind, where possible. If new glazing is installed, glazing is to be installed in existing wood sashes, if possible. New glazing should not have any coatings or films that would alter the appearance of the glass, and thus the historic front façade

- Inspect for condition and complete detailed inventory to determine extent of recommended repair or replacement of wood window of the retained front façade.
- Preserve original wood windows of retained front façade and repair as required using in kind repair techniques, where feasible; install

replacement matching sashes where missing or beyond repair.

- Overhaul, tighten/reinforce joints. Repair frame, trim.
- Each window should be made weather tight by re-puttying and weather-stripping as necessary.
- Retain historic glass, if possible. Where broken glass exists in historic wood-sash windows, the broken glass should be replaced.
- Window repairs should be undertaken by a contractor skilled in heritage restoration.
- If glazing is replaced, new glazing to be visually and physically compatible with the existing glazing installed in the existing wood sashes, if possible. Coatings, tints, or films to be used on glazing which would alter the heritage character of the building.
- Prime and repaint as required in appropriate colour, based on colour schedule devised by Heritage Consultant.
